Title of Investigation: 716 E. 27th Street Explosion	Investigation Number: 784020-21-0014	Report Number: 56
---	---	----------------------

ATF National Response Team (NRT) Origin and Cause Determination.

From 7/2/21 – 7/6/21, Bureau of Alcohol, Tobacco, Firearms and Explosives (ATF) National Response Team (NRT) and Los Angeles Police Department (LAPD) personnel conducted a post blast scene examination of an explosion that occurred while LAPD bomb squad personnel were conducting a disposal operation in a Total Containment Vessel (TCV). The explosion occurred on East 27th Street just east of San Pedro Street in the city of Los Angeles, CA. The classification of the explosion was accidental.

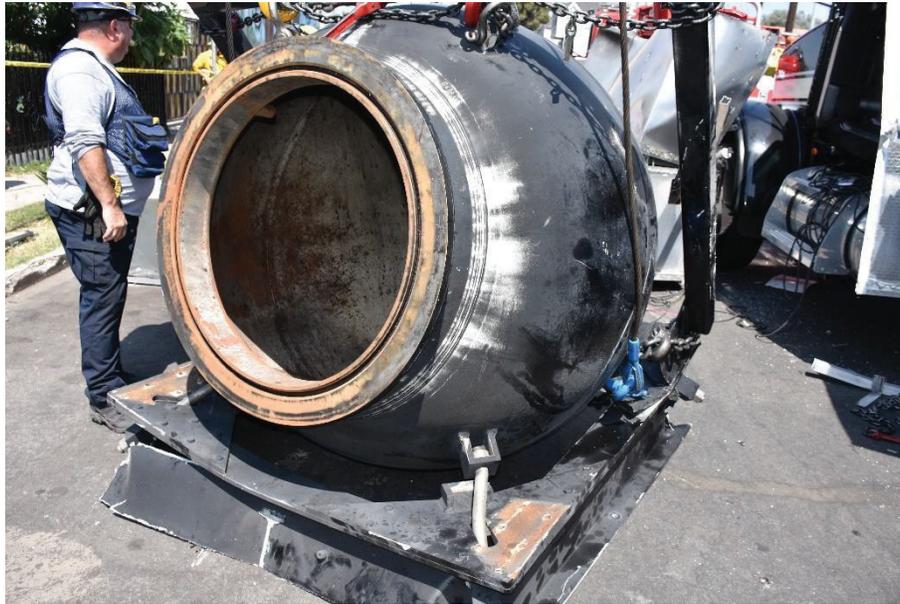
Figure 14: Picture showing vessel of the TCV.

93. The vessel of the TCV (See Figure 14) was removed from the vehicle. Two samples of the debris inside the vessel were removed and placed into gallon paint cans (ATF Items 5 and 6). The items were subsequently submitted to the ATF lab for analysis.

94. The fiducial marks on the vessel were measured using the procedure prescribed by the manufacturer. The measurements were consistent with the measurements of the fiducial marks taken prior to the explosion occurring on 6/30/21. This indicates there were no significant deformations of the vessel that resulted from the explosion event on 6/30/21.
95. A federal search warrant was conducted at 716 E 27th St. This is the location where more than 30,000 pounds of consumer fireworks were removed by LAPD on 6/30/21. Nothing significant to the explosion event that occurred in the TCV was located during the search of the residence.
96. The vessel and the components of the TCV that had been collected in the parking lot of Best Laundry were loaded onto a LAPD bomb squad trailer and taken to LAPD bomb squad HQ garage for storage.

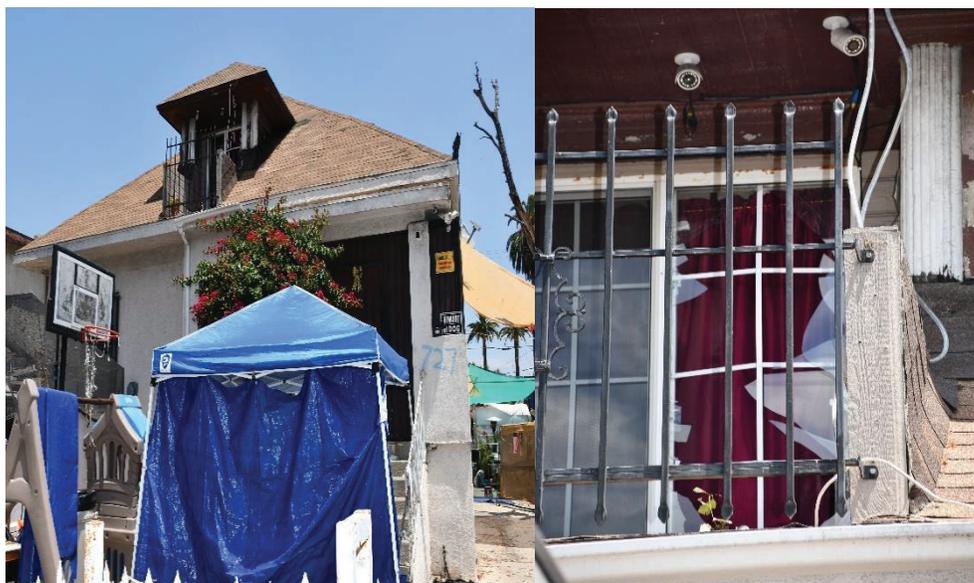
Structure Type: Residence
Address: 727 East 27th Street, Los Angeles, CA
Description: 3,750 square-foot multi-family residence
Damage: Yellow tagged by Los Angeles Department of Building and Safety. Broken windows and stucco

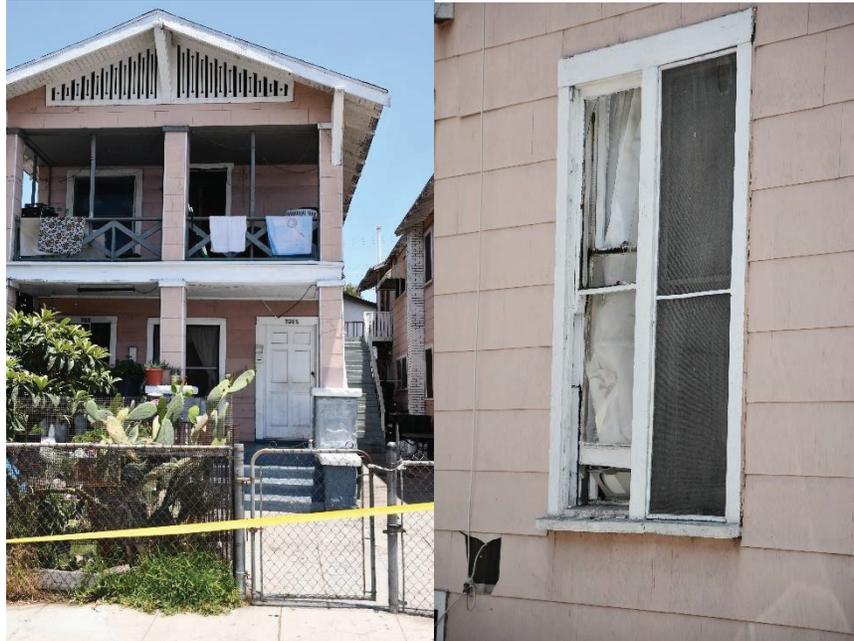
Structure Type: Residence
Address: 753 East 27th Street, Los Angeles, CA
Description: 1,824 square-foot residence
Damage: Broken windows, cracked siding and displaced columns

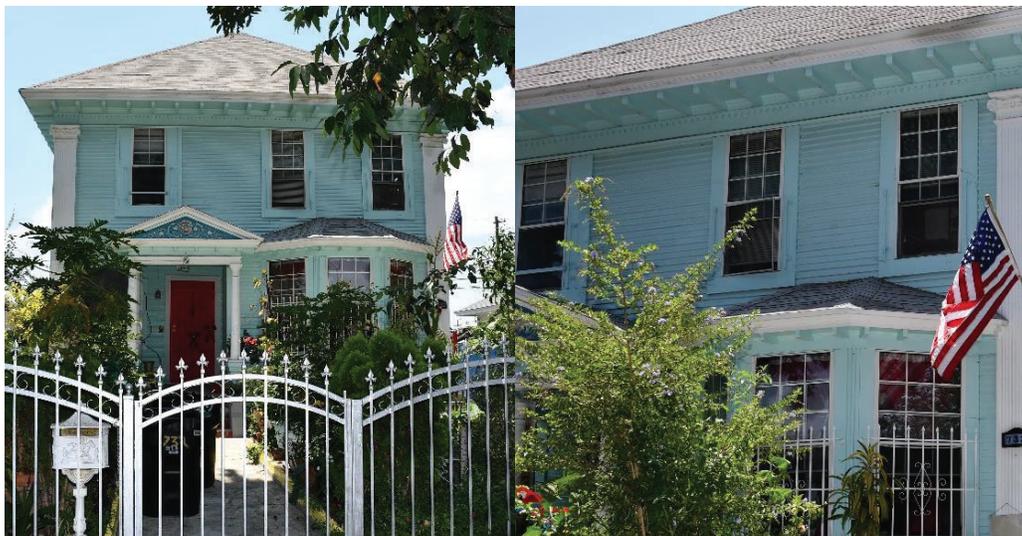
Structure Type: Residence
Address: 732 East 27th Street, Los Angeles, CA
Description: 1,737 square-foot residence
Damage: Broken windows

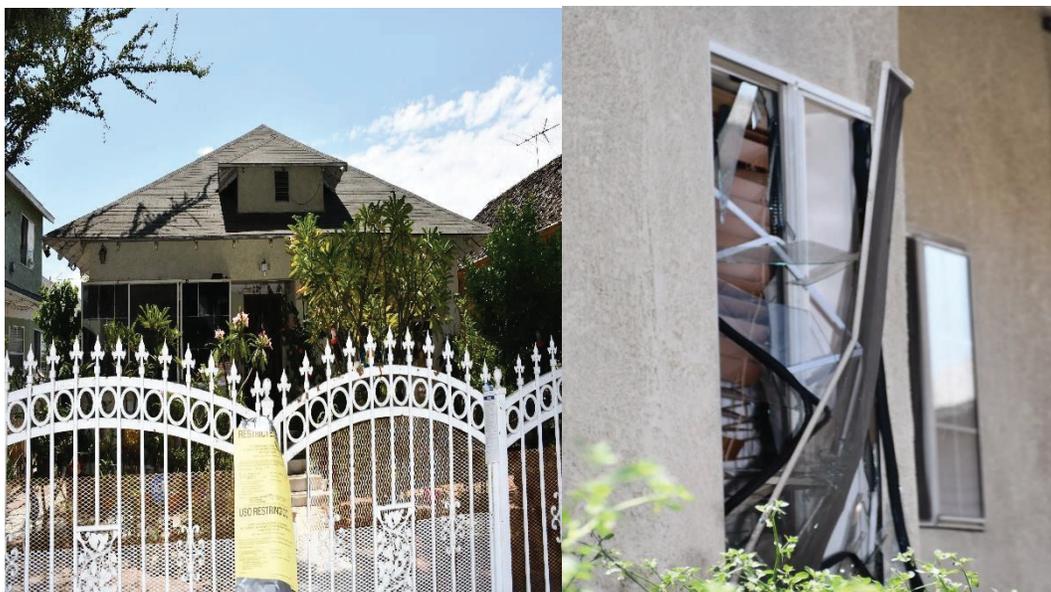
Structure Type: Residence
Address: 720 East 27th Street, Los Angeles, CA
Description: 1,387 square-foot residence
Damage: Yellow tagged by Los Angeles Department of Building and Safety. Broken windows

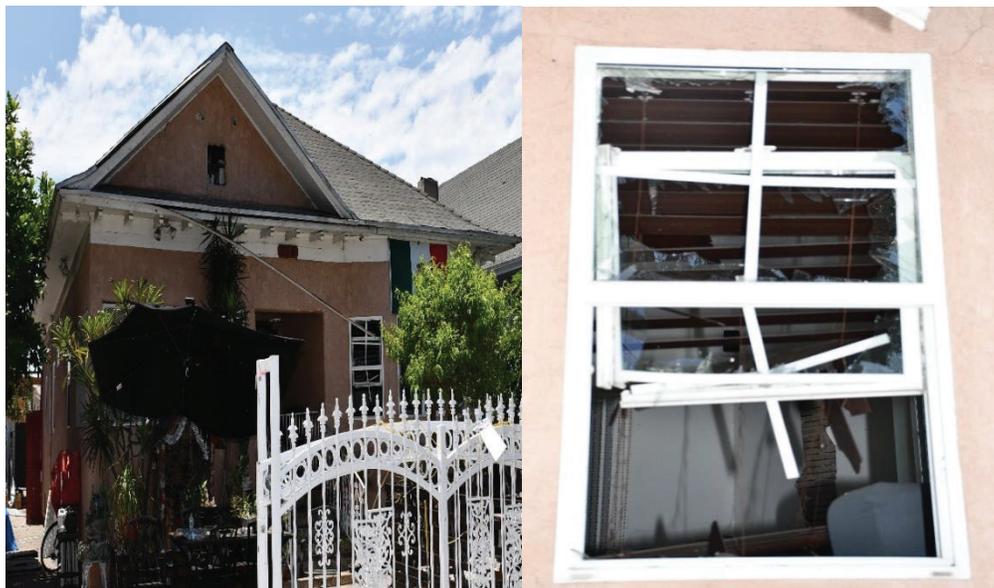
Structure Type: Residence
Address: 716 East 27th Street, Los Angeles, CA
Description: 1,270 square-foot residence
Damage: Broken windows and stucco, and damage to the roof.

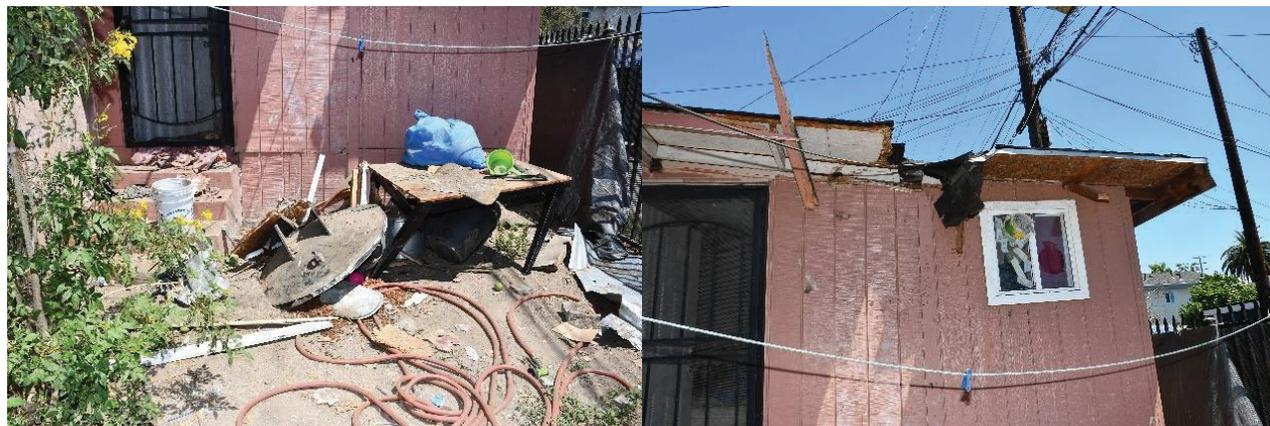
Structure Type: Residence
Address: 912 1/2 East Adams Boulevard, Los Angeles, CA
Description: 1,882 square-foot residence
Damage: Damage to wall, roof, and trees

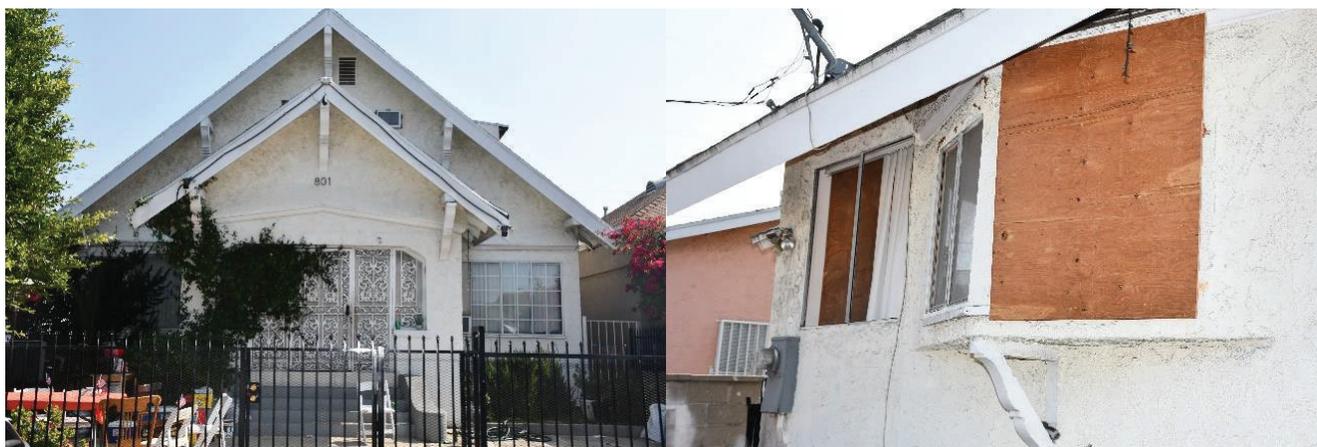
Structure Type: Residence
Address: 801 East 27th Street, Los Angeles, CA
Description: 1,344 square-foot residence
Damage: Broken windows

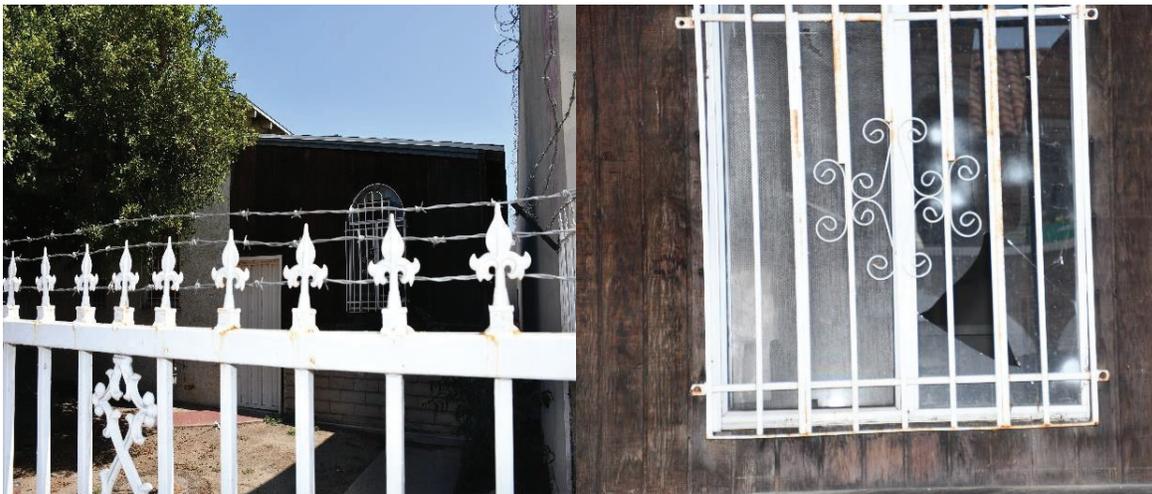
Structure Type: Residence
Address: 665 East Adams Boulevard, Los Angeles, CA
Description: 1,972 square-foot residence
Damage: Broken windows

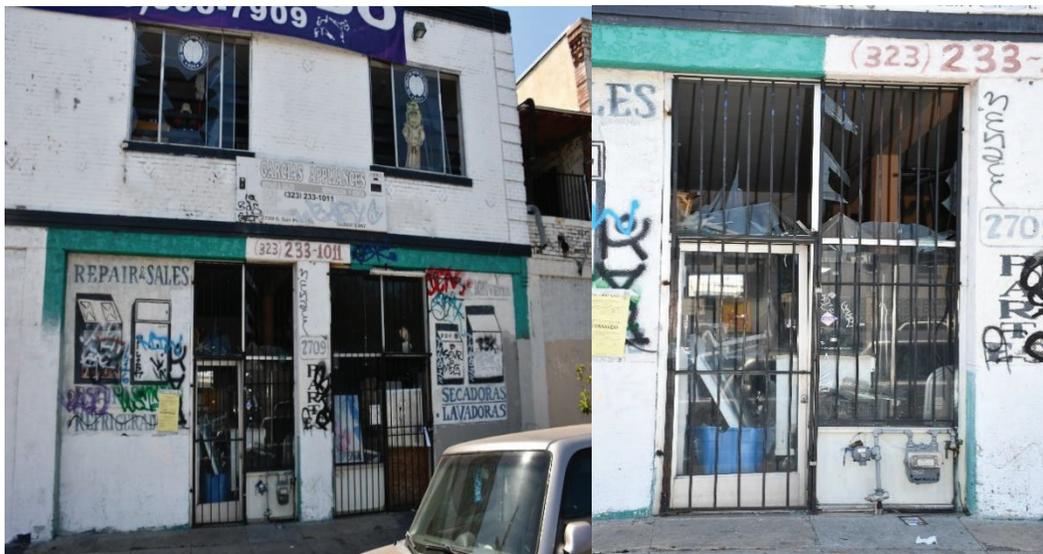
Structure Type: Commercial business
Address: 2709 South San Pedro Street, Los Angeles
Description: Garcia's Appliances
Damage: Yellow tagged by Los Angeles Department of Building and Safety. Damage to windows

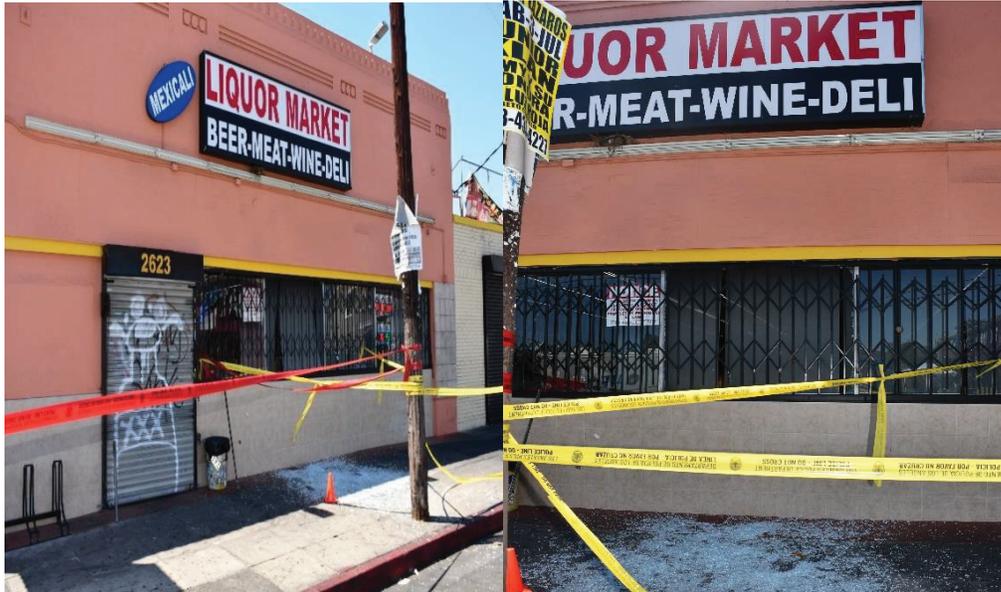
Structure Type: Commercial business
Address: 2623 South San Pedro Street, Los Angeles
Description: Mexicali Liquor Market
Damage: Damage to windows
