Title of Investigation: 716 E. 27th Street Explosion	Investigation Number: 784020-21-0014	Report Number: 56
---	---	----------------------

ATF National Response Team (NRT) Origin and Cause Determination.

From 7/2/21 – 7/6/21, Bureau of Alcohol, Tobacco, Firearms and Explosives (ATF) National Response Team (NRT) and Los Angeles Police Department (LAPD) personnel conducted a post blast scene examination of an explosion that occurred while LAPD bomb squad personnel were conducting a disposal operation in a Total Containment Vessel (TCV). The explosion occurred on East 27th Street just east of San Pedro Street in the city of Los Angeles, CA. The classification of the explosion was accidental.

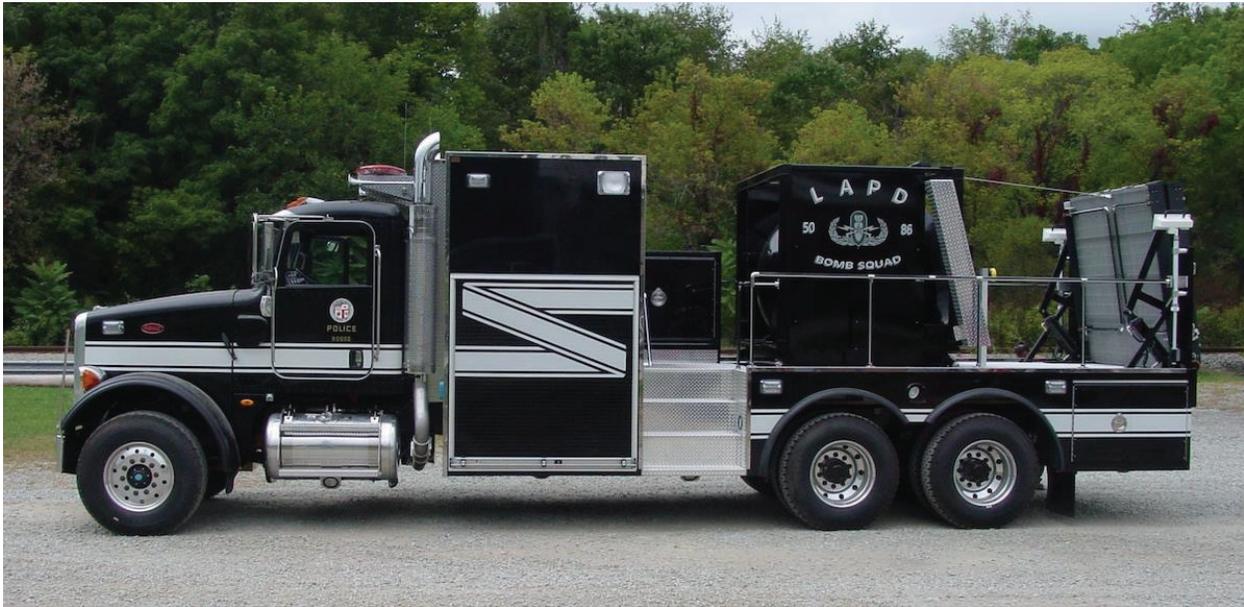
10. The affected vehicle was a 2009 Peterbilt Model 365 with VIN: 1NPSLU0XX9N777069 and bearing CA License Plate: 1242990. The truck was equipped with a NABCO, Model# 64 SCS, TCV attached to the frame of the vehicle and located above the twin rear axles. A folding metal ramp was located at the back of the vehicle to allow access to the door of the TCV. The door of the TCV faced the rear of the vehicle and was operated by a hydraulic system. See Figure 1.

Figure 1: LAPD TCV Vehicle

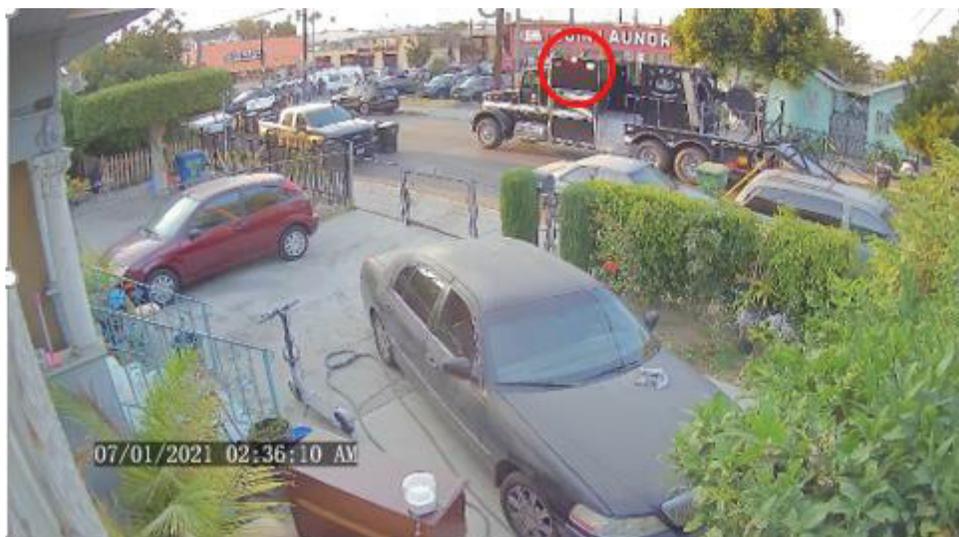
- On 6/30/21, at approximately 7:27 pm (offset time), the total containment vessel (TCV) appears in front of the residence at 712 East 27th Street and a light affixed to the top left portion of the vessel can be seen flashing. See Figure 2.

Figure 2: Picture showing TCV open and warning light illuminated

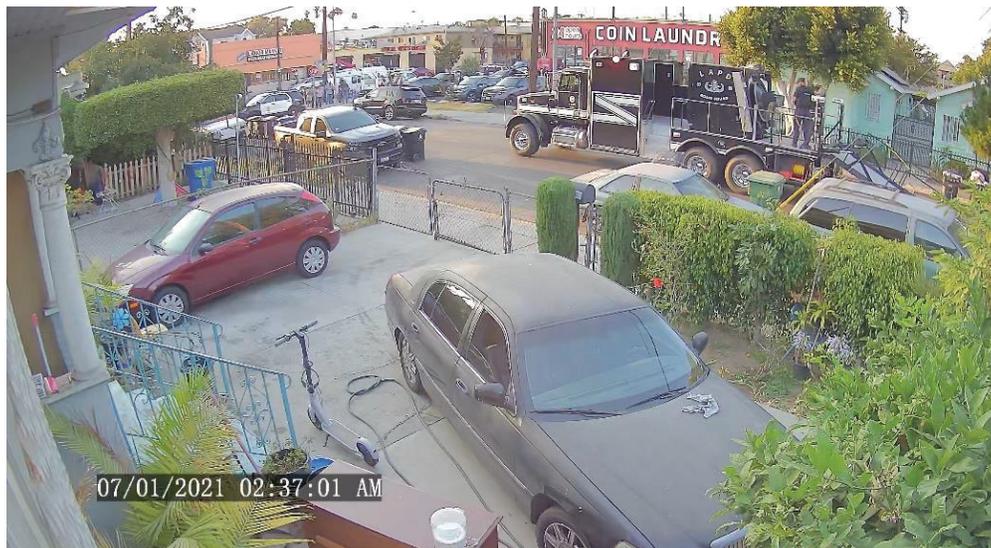
- Continuing the same date approximately one minute later, the door to the TCV can be seen closing. See Figure 3.

Figure 3: Picture showing TCV closing, and warning light illuminated.

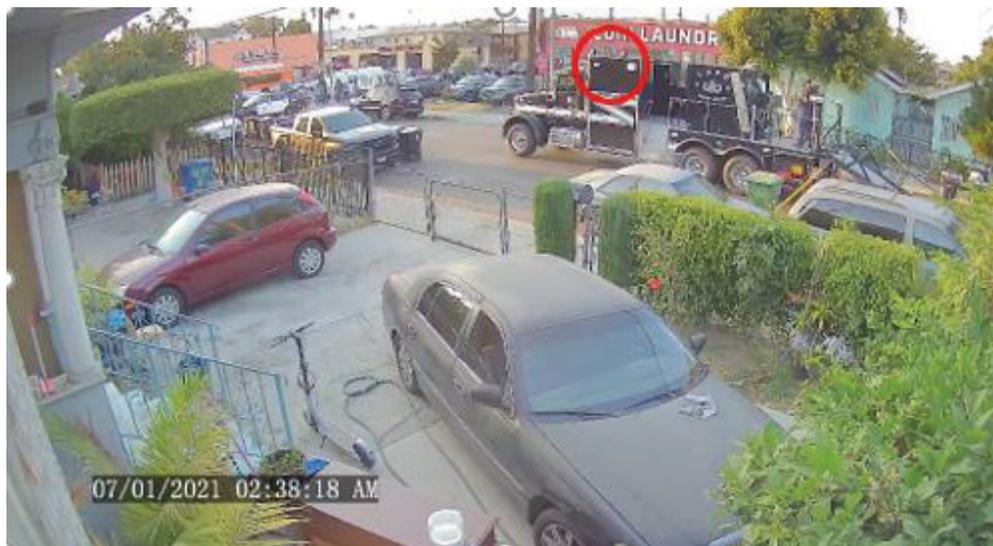
- Continuing the same date, approximately one minute later, the door to the TCV can be seen closed with the light turned off. See Figure 4.

Figure 4: Picture showing TCV closed and warning light off

66. The two videos show the TCV door close and the warning lights go off. This is evidence the TCV was closed and properly operating just prior to the explosion. The videos also show the explosion occurred when initiated by the bomb squad and the explosion occurred at the back of the TCV vehicle.

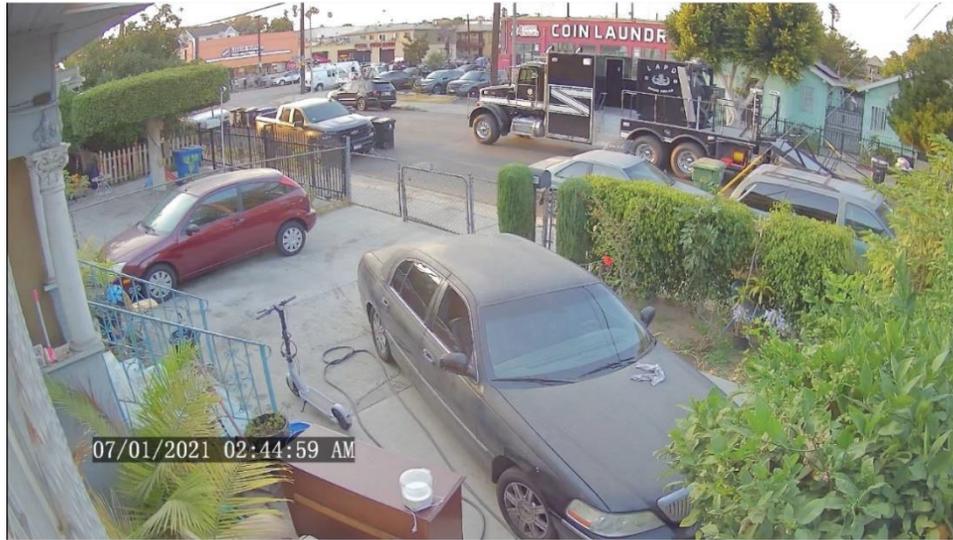
- On 6/30/21, at approximately 7:35pm (offset time), the total containment vessel (TCV) appears in front of the residence at 712 East 27th Street in working order. See Figure 5.

Figure 5: Picture showing TCV vehicle just prior to explosion.

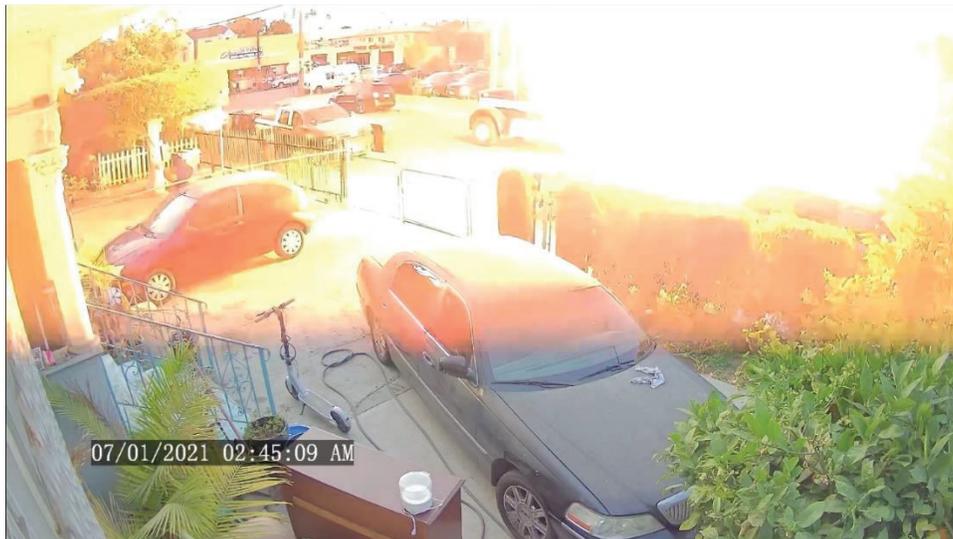
- Continuing the same date seconds later, a fire ball is observed towards the back end of the TCV, followed by smoke and debris can be seen in front of the residence. See Figure 6 and 7.

Figure 6: Picture showing fireball coming from rear of TCV vehicle.

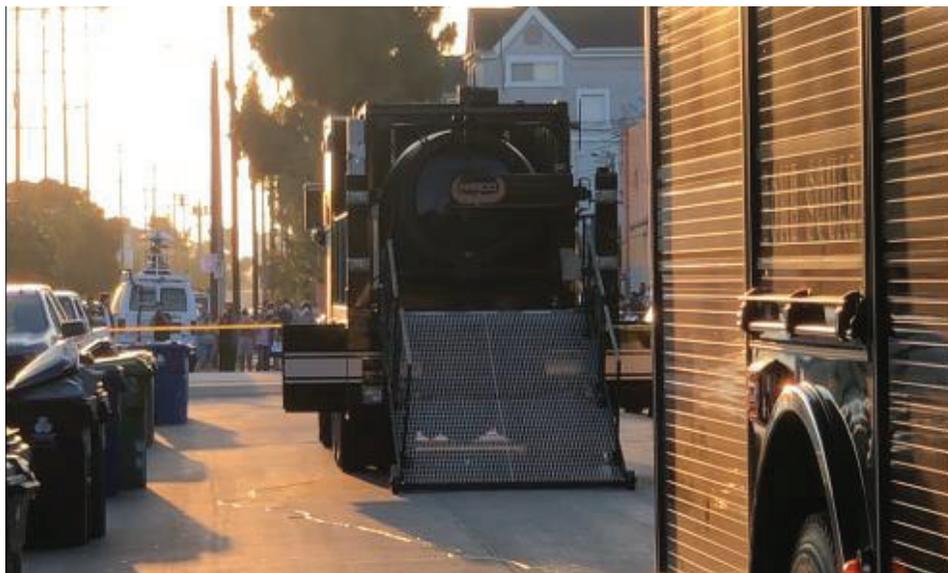
64. Investigators reviewed video captured by [REDACTED] one of the LAPD bomb technicians on scene the day of the explosion. The short video shows the initiation sequence of the explosion. The video also contains audio. The video begins with the TCV in view and off camera a loud voice can be heard shouting, “Fire in the hole, fire in the hole, fire in the hole.” This is a common warning given prior to the initiation of an explosion. See Figure 8.

Figure 8: Picture showing TCV just prior to explosion

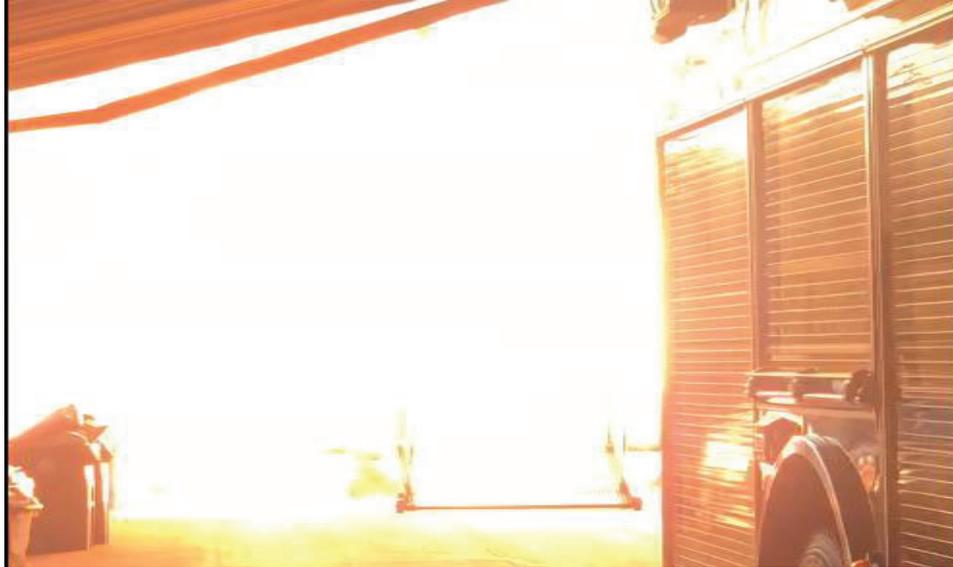
65. Immediately after the three “fire in the holes” are heard, a countdown of 3-2-1 can be heard. This countdown is usually performed by the person initiating the explosion so other participants in the explosives operation have a precise time when the explosion will occur. Immediately after 1 is heard in the countdown, the explosion occurs. See Figure 9.

Figure 9: Picture showing fireball at rear of TCV vehicle immediately after countdown.

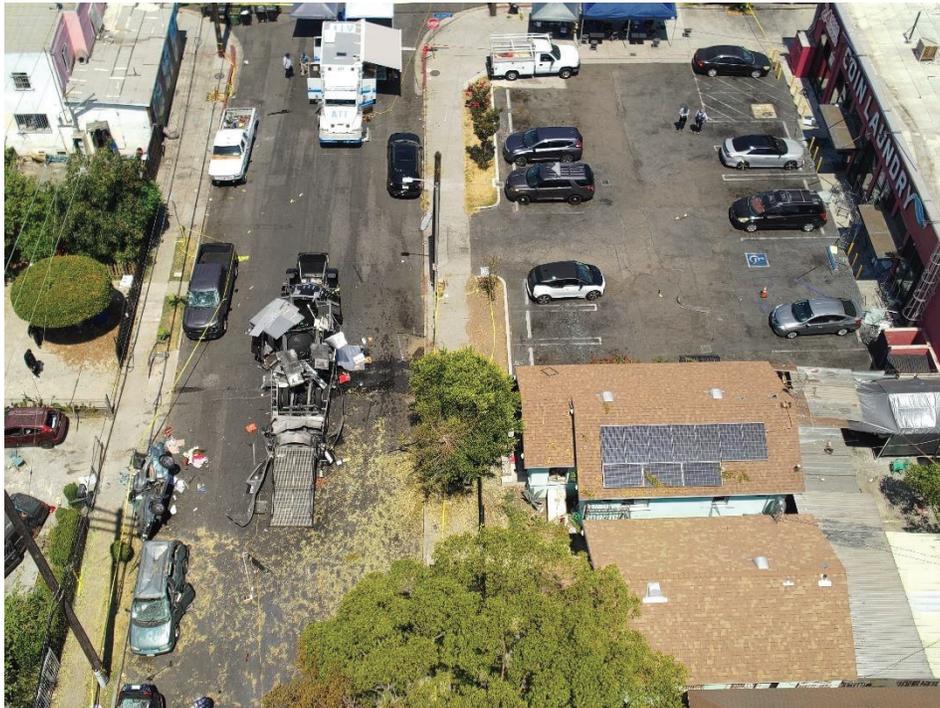
Figure 11: Picture showing the scene prior to processing.

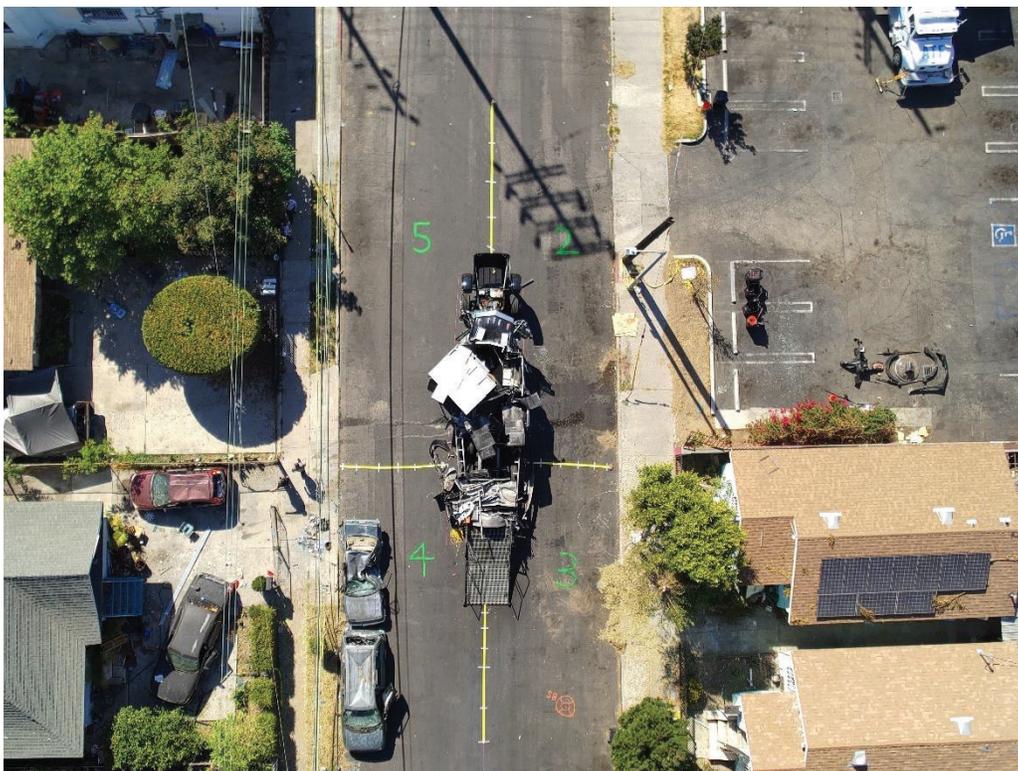
Figure 12: Picture showing section locations and TCV part collection area.

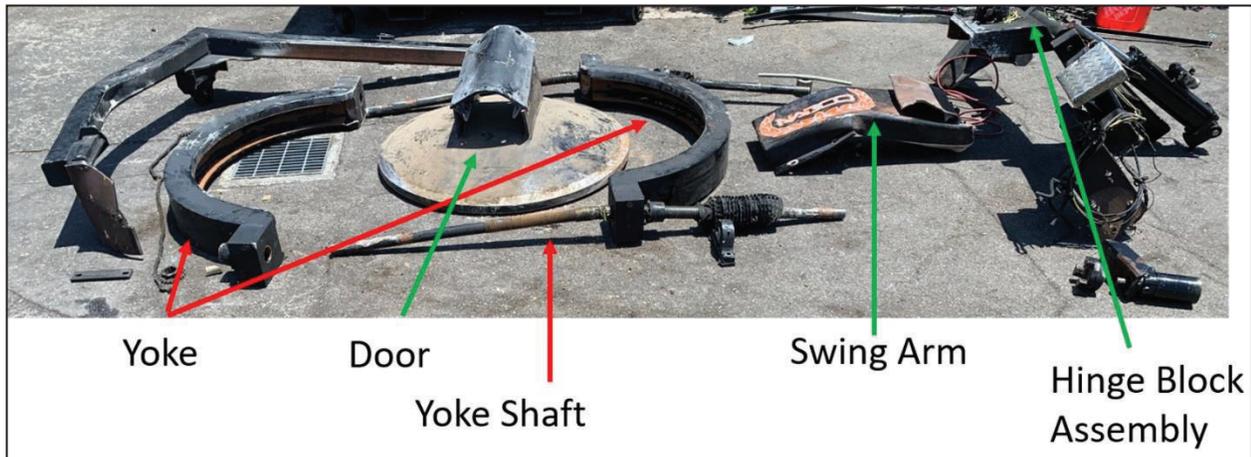
Item 012: TCV yoke half (left half if facing TCV from rear). Located in section 4. This item was imbedded in a car parked on E 27th in front of 712 E 27th St, weighed approximately 270 pounds. (ATF Item 37)

Item 013: TCV door hinge structure and frame. Located in section 3 in the backyard of 713/715 E 27th St, weighed approximately 200 pounds. (ATF Item 38)

Figure 13: Picture showing reconstruction of TCV parts.

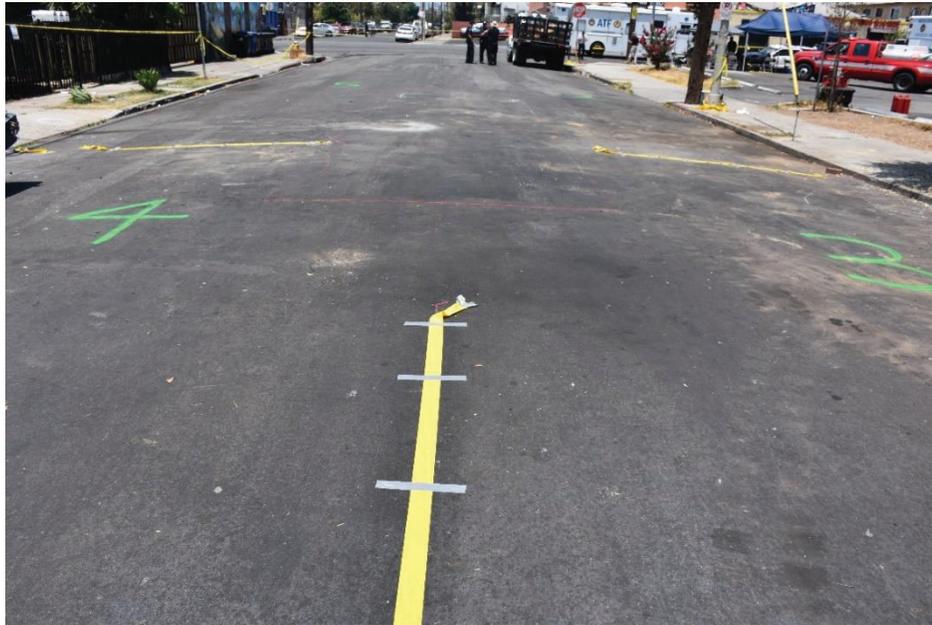
97. On 7/5/21 the remains of the Peterbilt chassis were removed and a final search of the area around the truck was conducted. Investigators continued to get consent to search addresses at the west end of E 27th St and do searches of those addresses for which consent was obtained. No significant items were located during the consent searches nor during the final search of the area around the truck. See Figure 15.

Figure 15: Picture showing scene after removal of TCV vehicle.

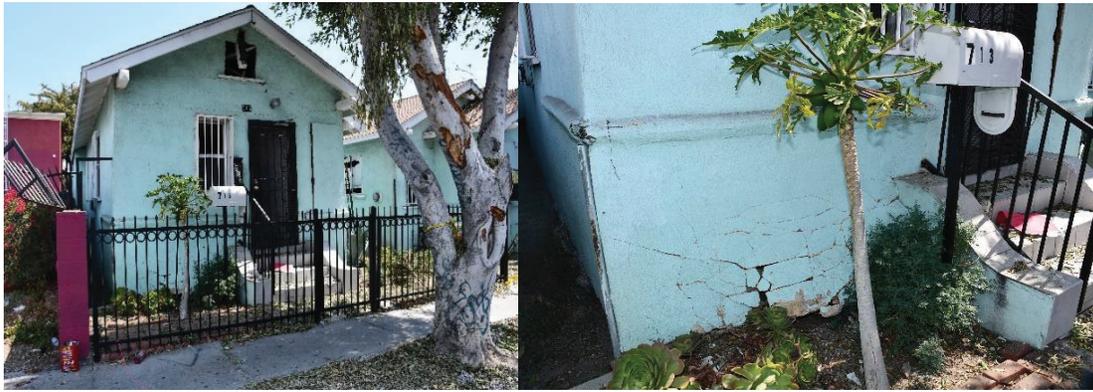
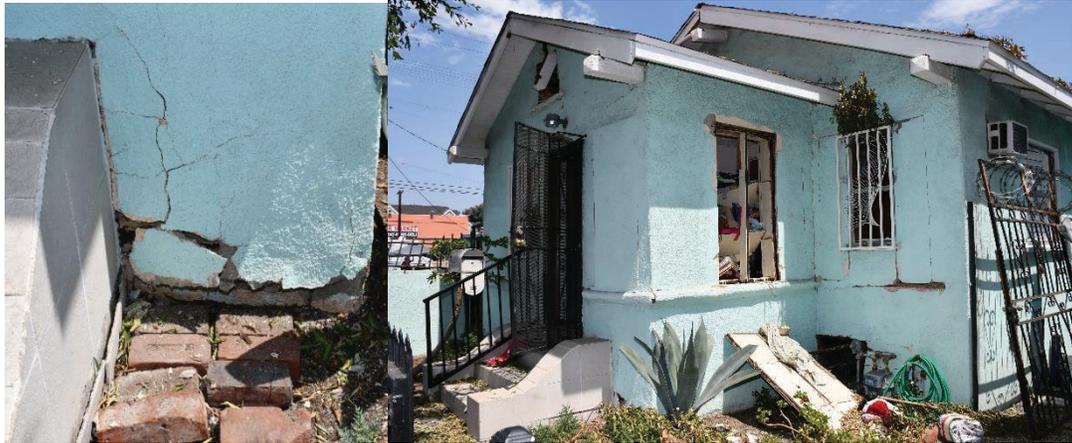
Structure Type:	Residence
Address:	713 East 27 th Street, Los Angeles, CA
Description:	1,328 square-foot residence
Damage:	Red tagged by Los Angeles Department of Building and Safety. Displaced and fractured walls, broken windows and framing, cracked stucco, and a damaged gas meter

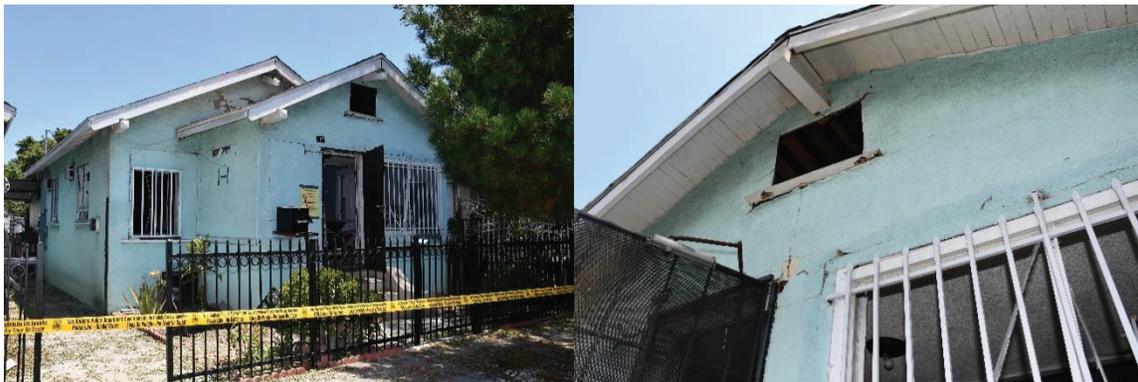
Structure Type: Residence
Address: 715 East 27th Street, Los Angeles, CA
Description: 1,120 square-foot residence
Damage: Yellow tagged by Los Angeles Department of Building and Safety. Displaced and fractured walls, broken windows and framing, cracked stucco, and a damaged gas meter

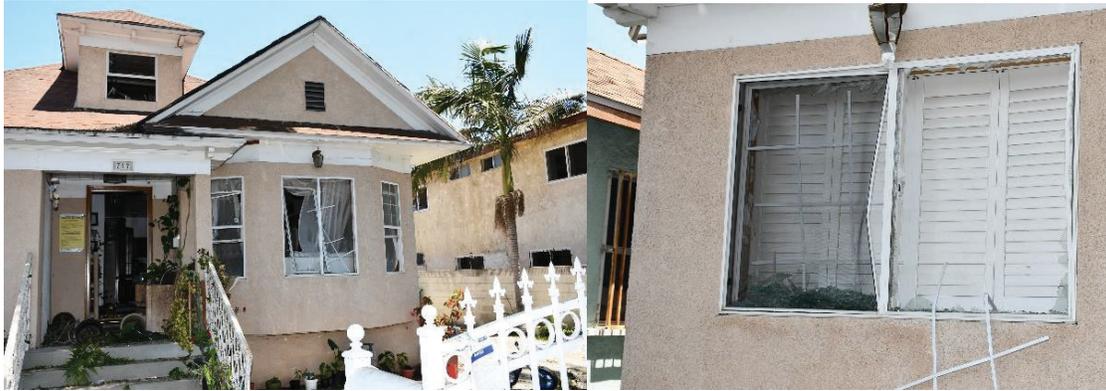
Structure Type: Residence
Address: 717 East 27th Street, Los Angeles, CA
Description: 1,215 square-foot residence
Damage: Yellow tagged by Los Angeles Department of Building and Safety. Broken windows, cracked stucco, and a damaged front door

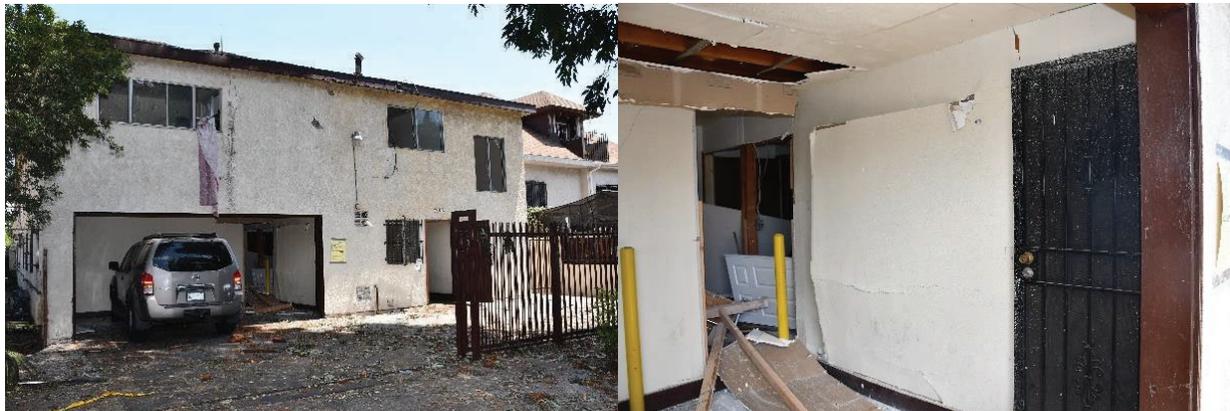
Structure Type: Residence
Address: 725 East 27th Street, Los Angeles, CA
Description: 6,334 square-foot multi-family residence
Damage: Yellow tagged by Los Angeles Department of Building and Safety. Damaged walls and garage, broken windows, and cracked stucco

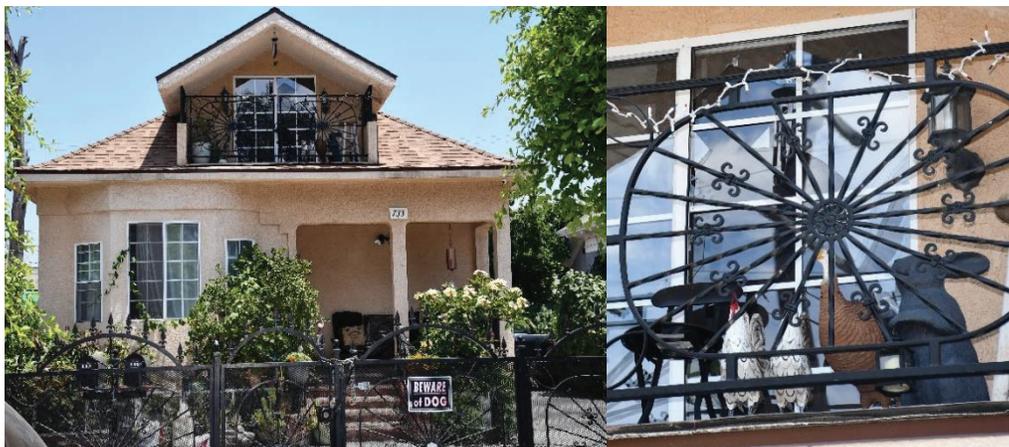
Structure Type: Residence
Address: 733 East 27th Street, Los Angeles, CA
Description: 738 square-foot residence
Damage: Broken windows

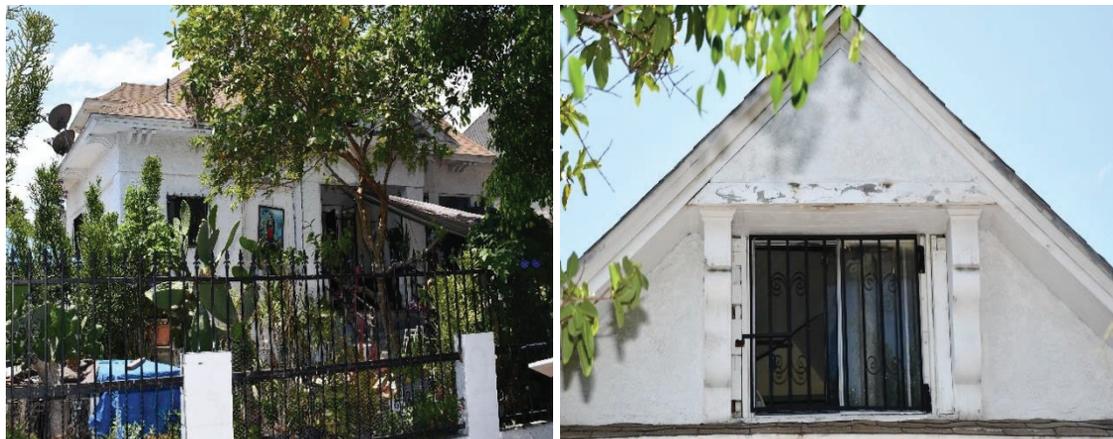
Structure Type: Residence
Address: 752 East 27th Street, Los Angeles, CA
Description: 2,232 square-foot residence
Damage: Broken windows

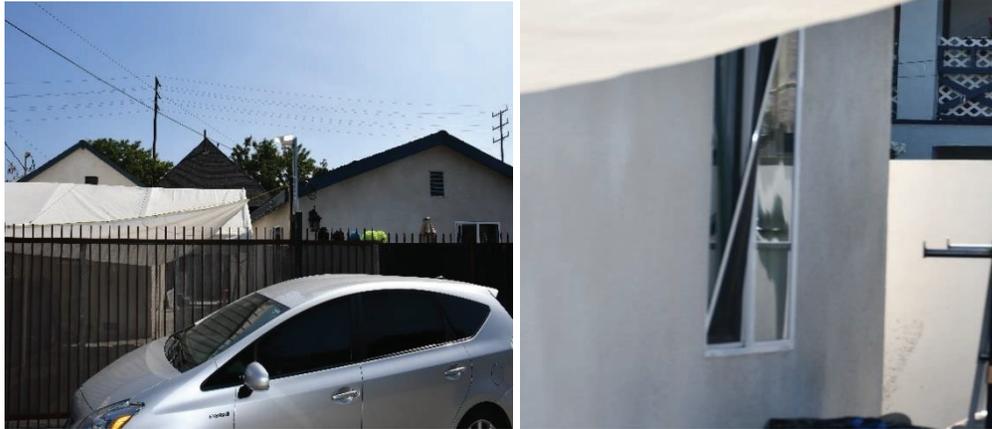
Structure Type: Residence
Address: 748 East 27th Street, Los Angeles, CA
Description: 1,534 square-foot residence
Damage: Broken window

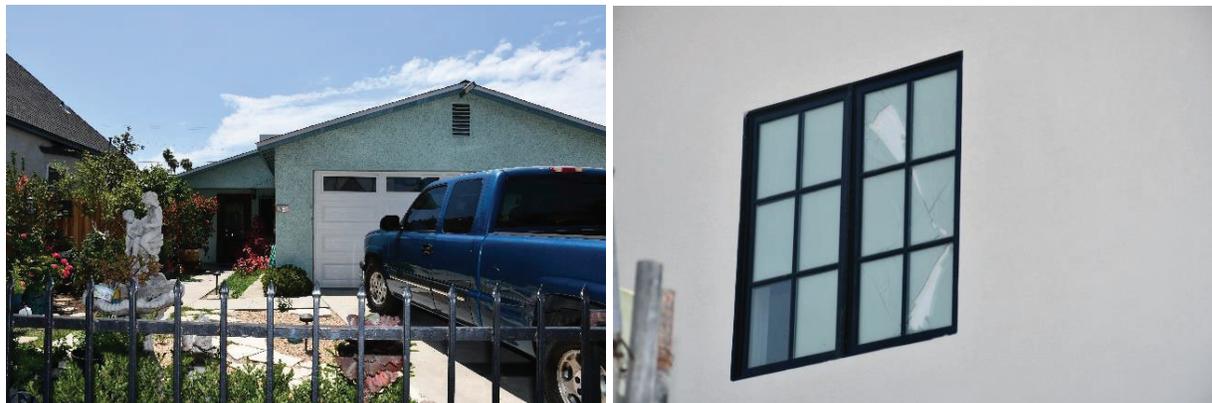
Structure Type: Residence
Address: 742 East 27th Street, Los Angeles, CA
Description: 930 square-foot residence
Damage: Broken windows

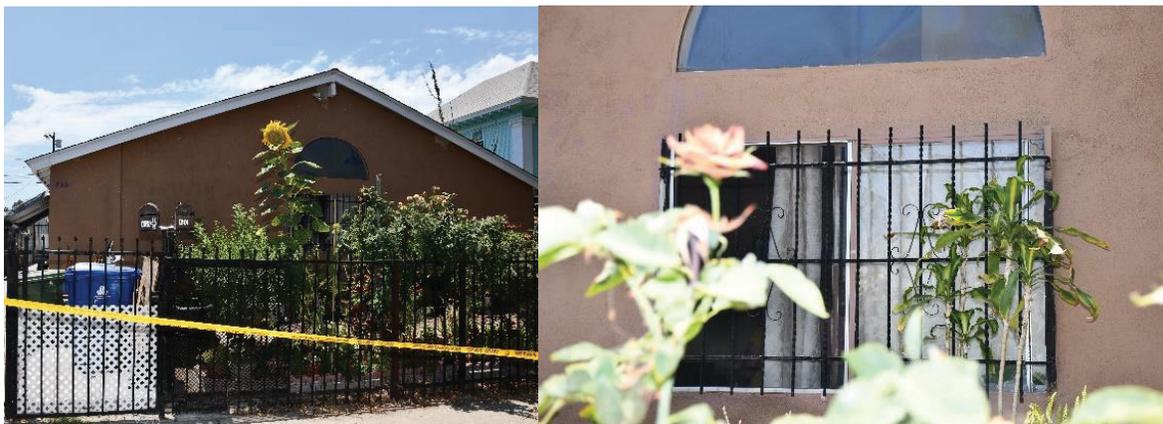
Structure Type: Residence
Address: 736 East 27th Street, Los Angeles, CA
Description: 2,192 square-foot residence
Damage: Broken windows

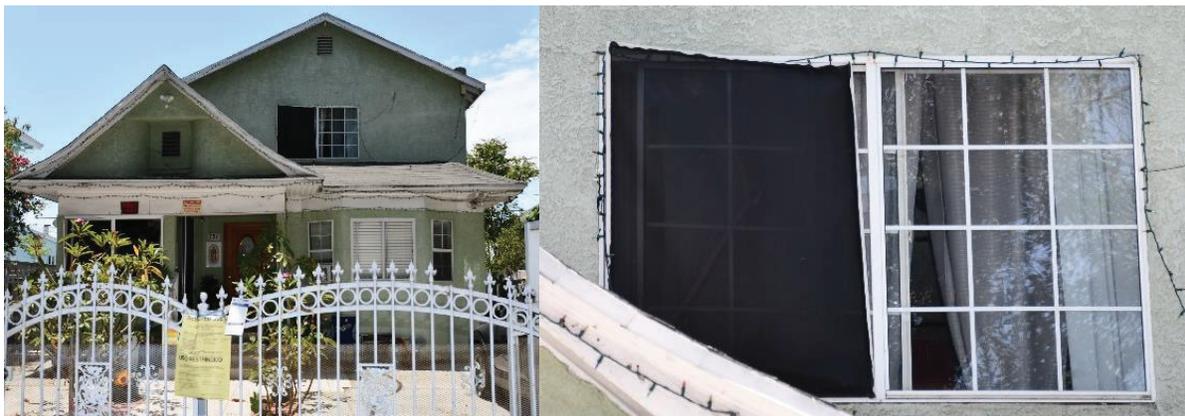
Structure Type: Residence
Address: 726 East 27th Street, Los Angeles, CA
Description: 1,911 square-foot residence
Damage: Yellow tagged by Los Angeles Department of Building and Safety. Broken windows

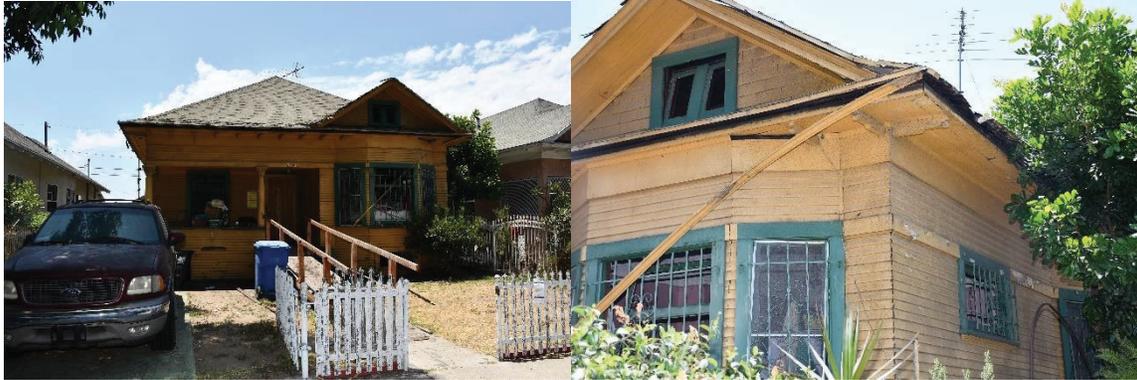
Structure Type: Residence
Address: 718 East 27th Street, Los Angeles, CA
Description: 1,270 square-foot residence
Damage: Yellow tagged by Los Angeles Department of Building and Safety. Broken windows, dislodged siding, and damage to the roof. Vehicle: Ford Expedition (CA 6RNX980) in driveway with broken windows

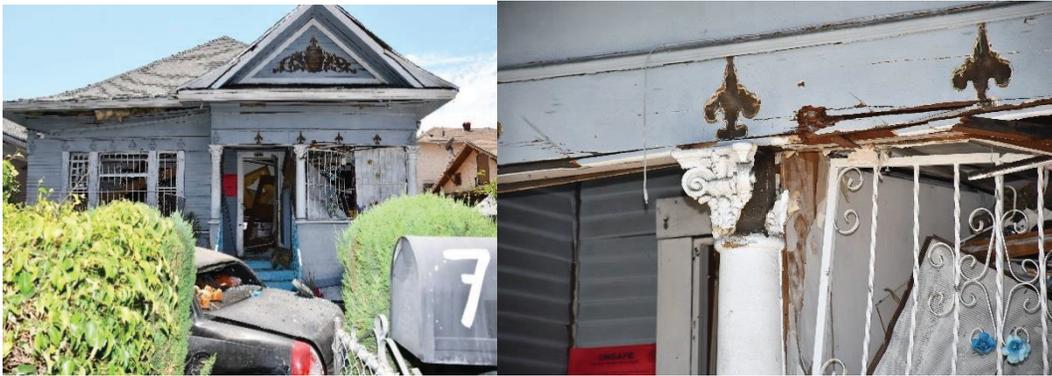
Structure Type: Residence
Address: 712 East 27th Street, Los Angeles, CA
Description: 1,262 square-foot residence
Damage: Red tagged by Los Angeles Department of Building and Safety. Broken windows, damage to wood framing and roof. Vehicles: Ford Focus (CA 6XEP119) and Lincoln Sedan (CA 63780Z1) in driveway with broken windows, large dents and roof damage.

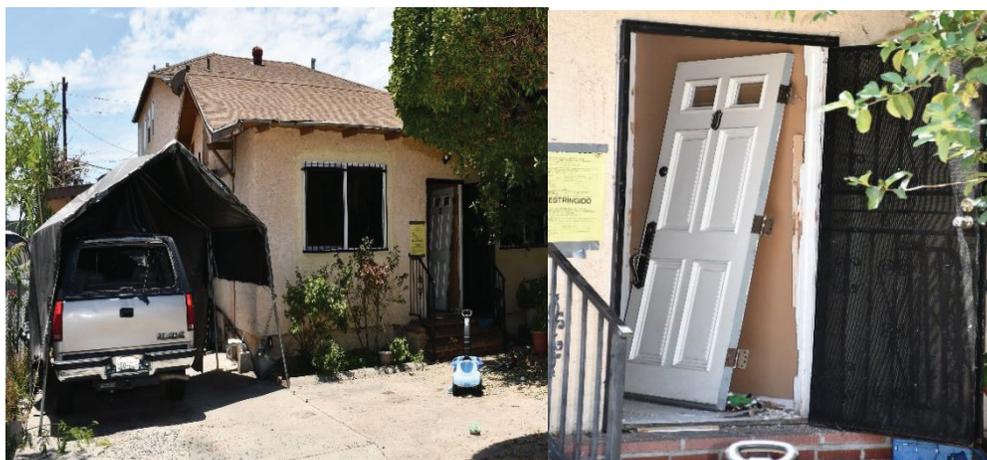
Structure Type: Residence
Address: 706 East 27th Street, Los Angeles, CA
Description: 2,114 square-foot multi-family residence
Damage: Yellow tagged by Los Angeles Department of Building and Safety. Broken windows, dislodged door, and damage to the roof. Vehicle: Chevrolet Suburban (CA 4DQE643) in driveway with broken windows

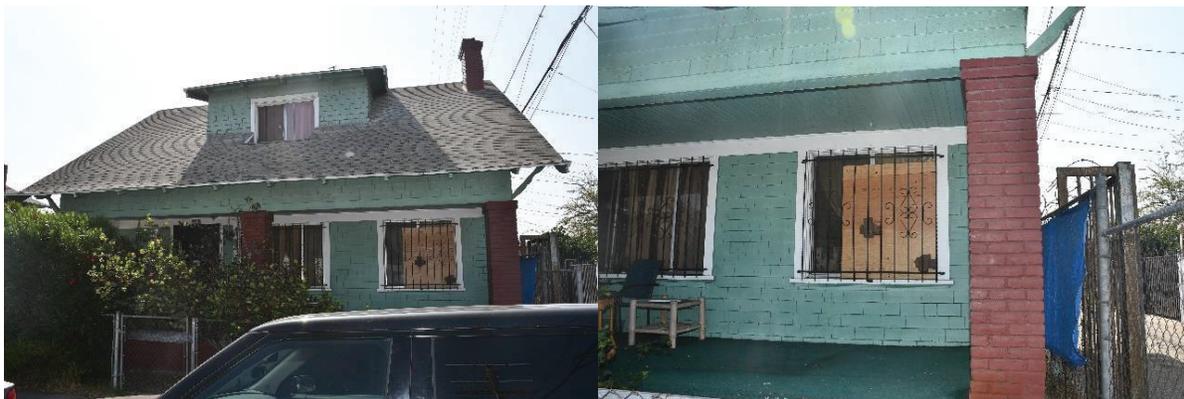
Structure Type: Residence
Address: 2612 Stanford Avenue, Los Angeles, CA
Description: 600 square-foot residence
Damage: Broken windows

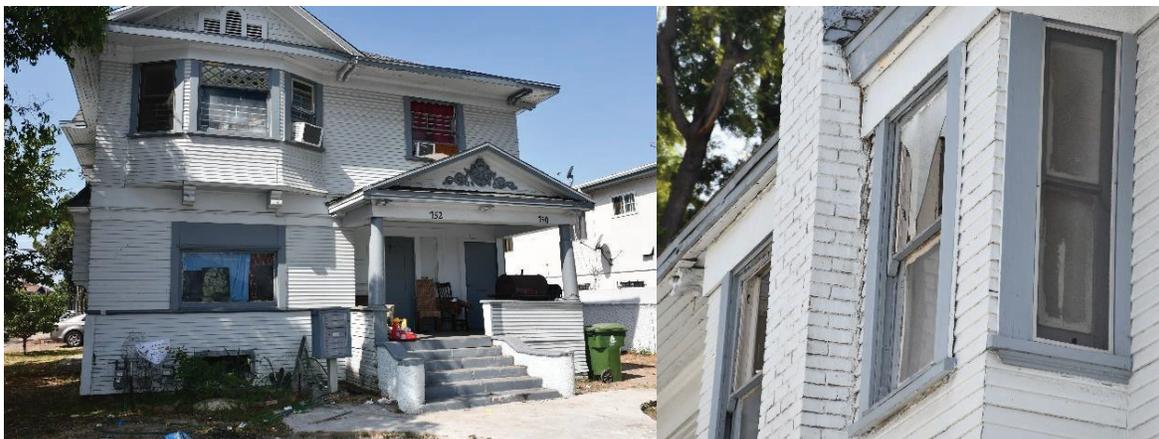
Structure Type: Residence
Address: 750 East Adams Boulevard, Los Angeles, CA
Description: 2,874 square-foot residence
Damage: Broken windows

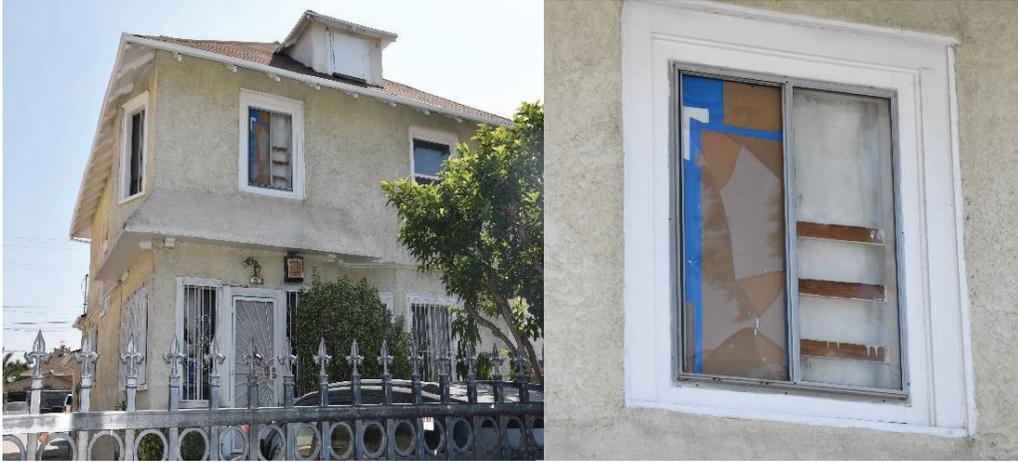
Structure Type: Residence
Address: 747 East Adams Boulevard, Los Angeles, CA
Description: 2,853 square-foot residence
Damage: Broken windows

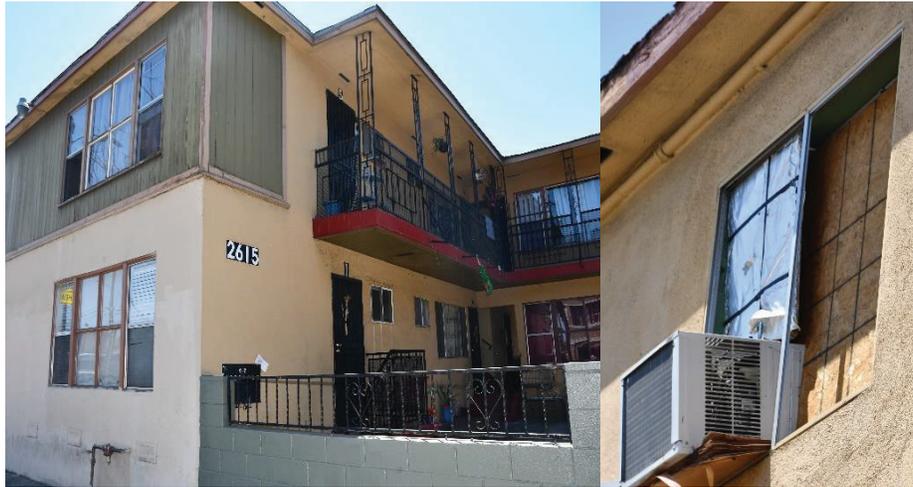
Structure Type: Residence
Address: 2615 South San Pedro Street, Los Angeles, CA
Description: Multiple unit apartment residence
Damage: Broken windows

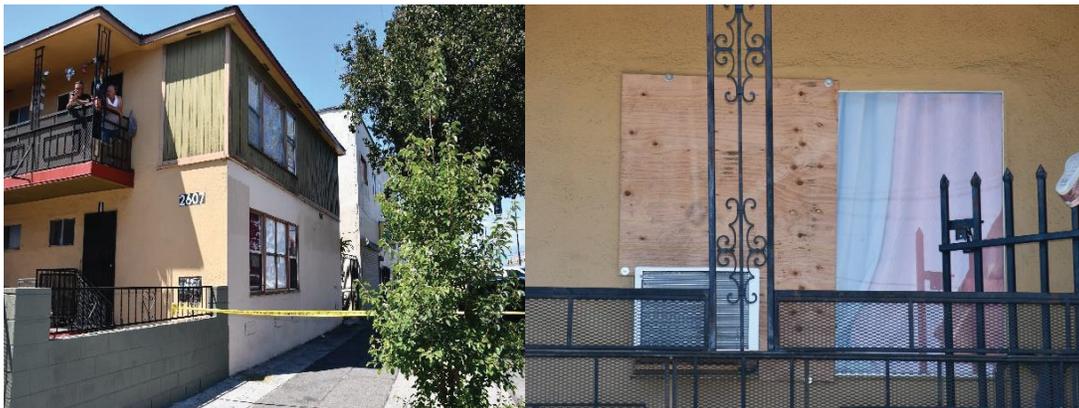
Structure Type: Residence
Address: 2617 South San Pedro Street, Los Angeles, CA
Description: Multiple unit apartment residence
Damage: Broken windows

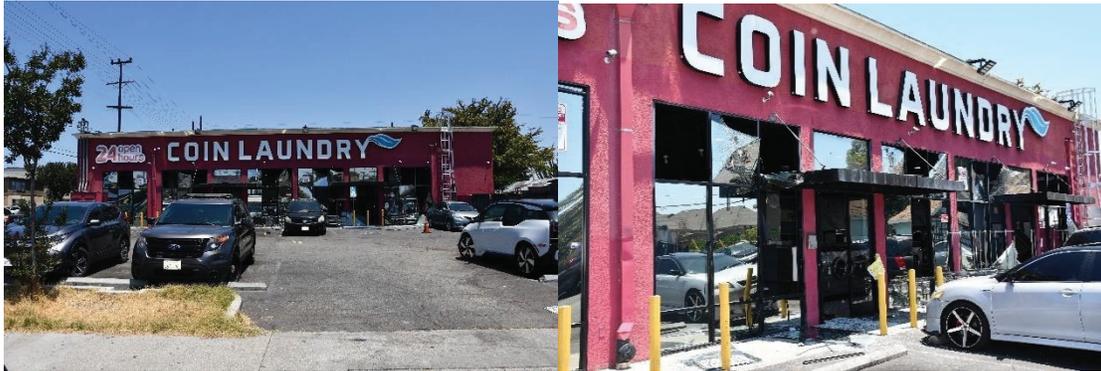
Description: Coin Laundry

Damage: Yellow tagged by Los Angeles Department of Building and Safety. Broken windows and damaged door

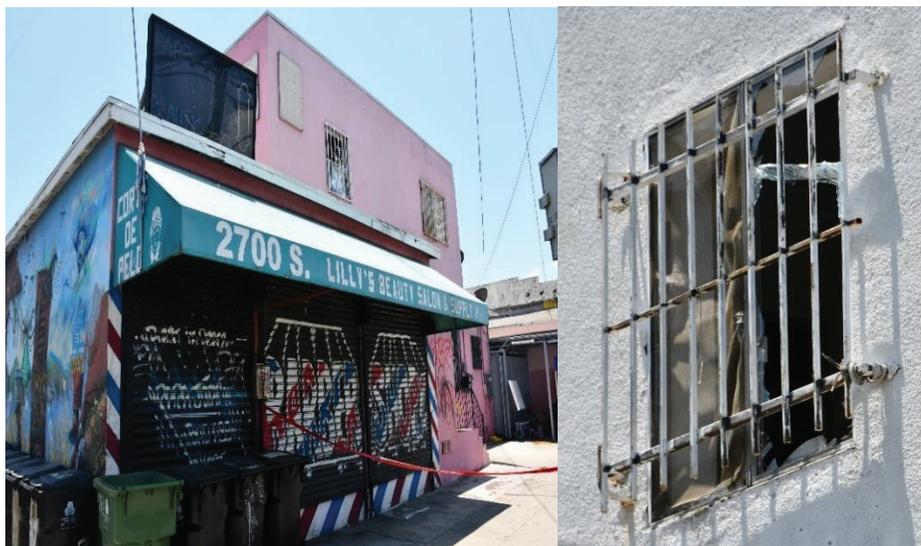
Description: Lilly's Beauty Salon & Supplies

Damage: Damage to rolling gate and windows

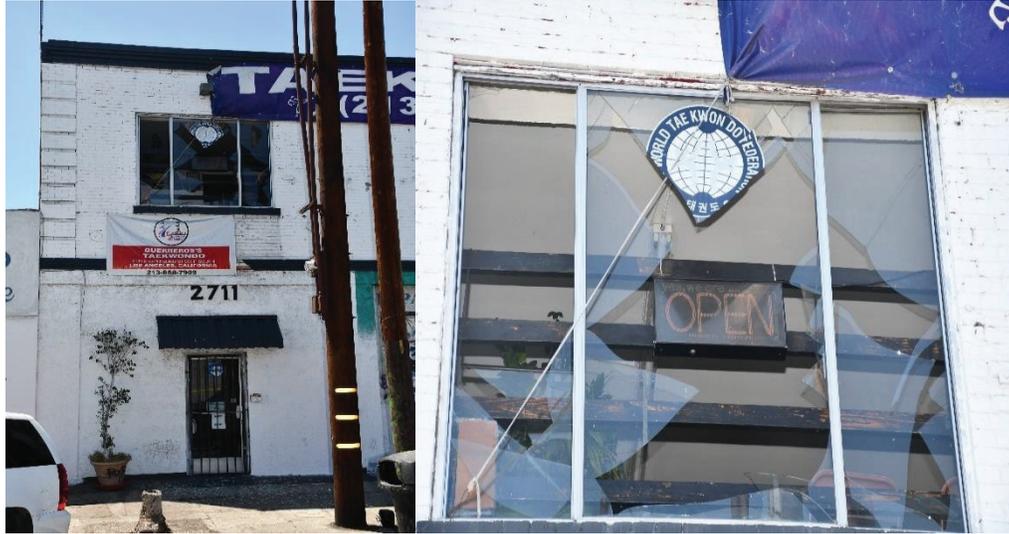
Structure Type: Commercial business
Address: 2711 South San Pedro Street, Los Angeles
Description: Guerrero's Taekwondo
Damage: Yellow tagged by Los Angeles Department of Building and Safety. Damage to windows

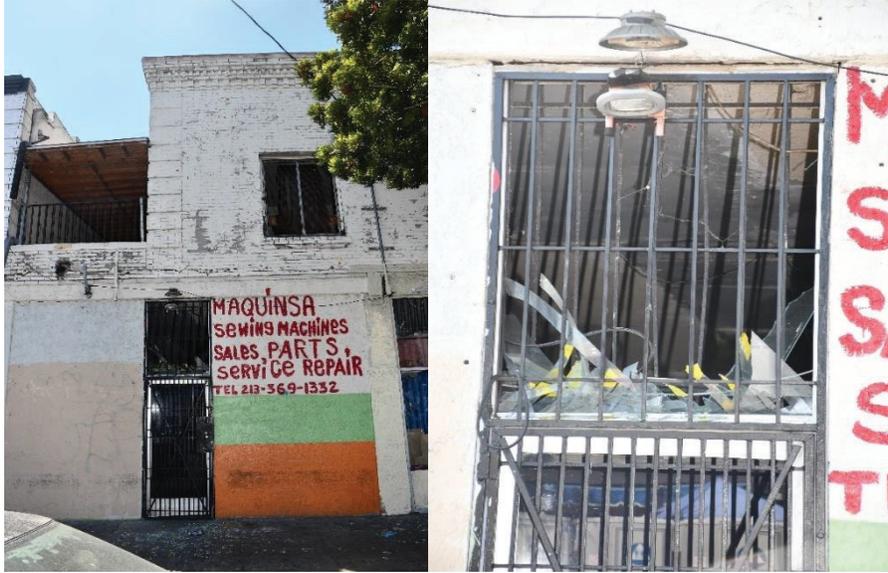
Structure Type: Commercial business
Address: 2703 South San Pedro Street, Los Angeles
Description: Maquinsa Sewing Machines
Damage: Yellow tagged by Los Angeles Department of Building and Safety. Damage to windows

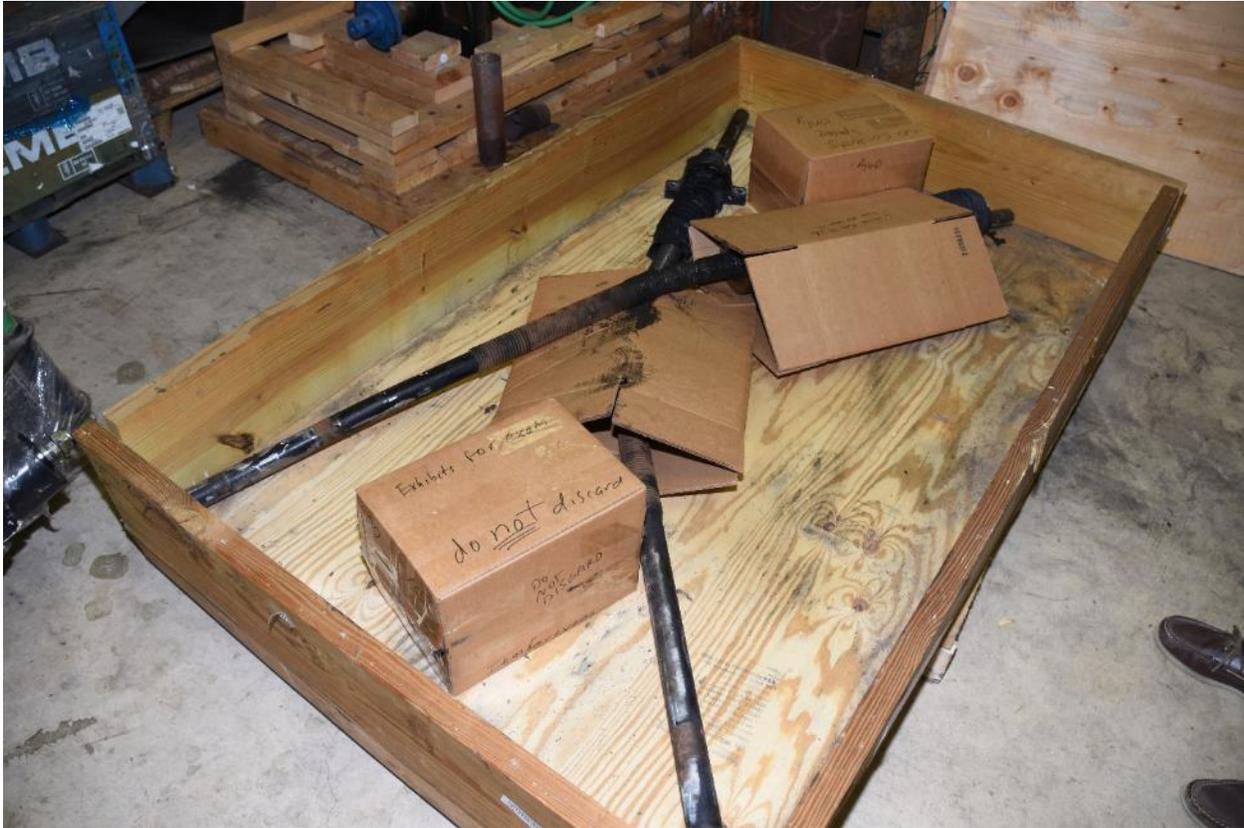
FIGURE 1

The components as received are shown in Figure 1.

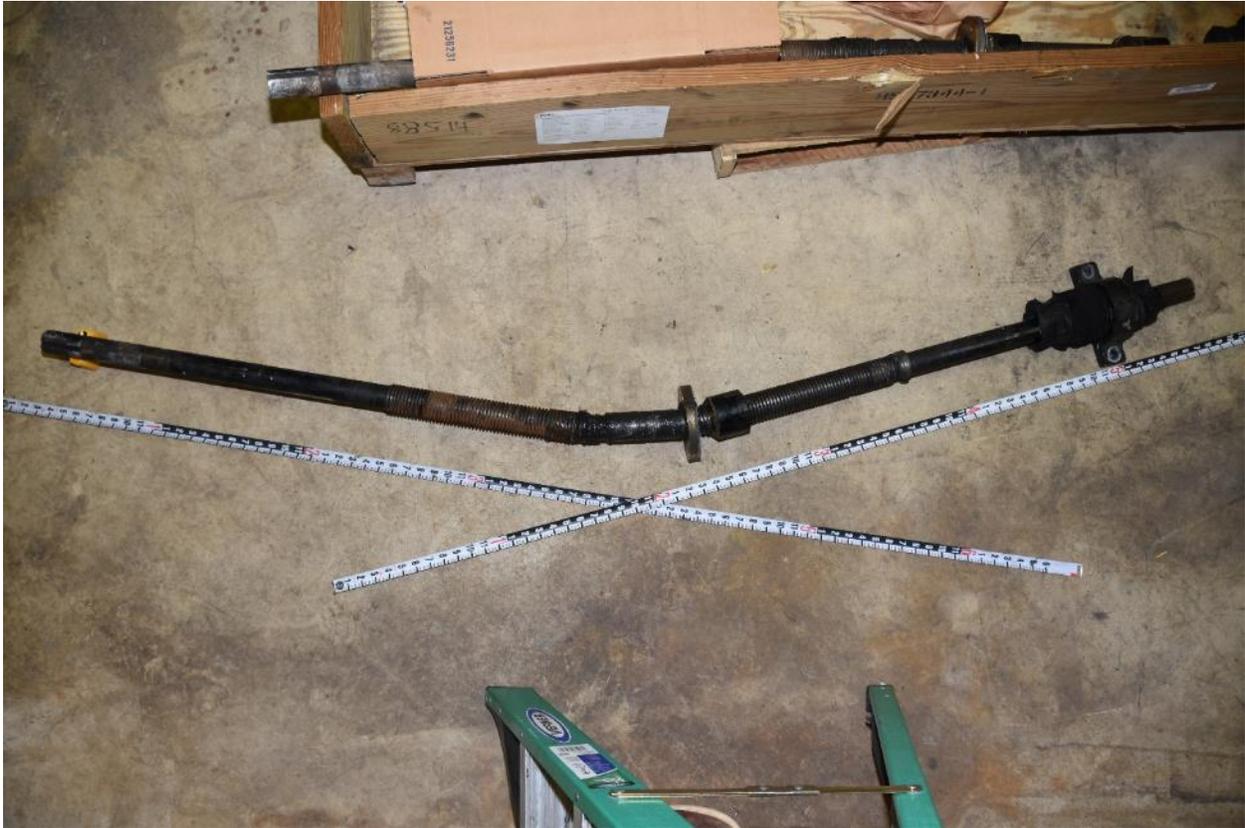
FIGURE 2

The upper threaded rod is shown in Figure 2. Figure 3 shows that the bronze threads of the left (driver's) side flanged collar have been shear off and remain in the threads of the steel rod. Figure 4 shows that the right (passenger's) side flanged collar has broken. The flange is broken away from the rest of the collar. The threads that had been inboard of the flange have been sheared off and remain in the mating threads of the steel rod. The threads of the remainder of the collar are still intact and that portion of the collar turns freely on the steel threaded rod. The flanged collar that had been attached to the top of left side yoke (based on site photographs) is shown in Figures 5 and 6. All the threads have been sheared from this collar, the collar has a crack on a radial-axial plane through one of the bolt holes, and a piece of the collar is broken away.
