Title of Investigation: 716 E. 27th Street Explosion	Investigation Number: 784020-21-0014	Report Number: 56
---	---	----------------------

ATF National Response Team (NRT) Origin and Cause Determination.

From 7/2/21 – 7/6/21, Bureau of Alcohol, Tobacco, Firearms and Explosives (ATF) National Response Team (NRT) and Los Angeles Police Department (LAPD) personnel conducted a post blast scene examination of an explosion that occurred while LAPD bomb squad personnel were conducting a disposal operation in a Total Containment Vessel (TCV). The explosion occurred on East 27th Street just east of San Pedro Street in the city of Los Angeles, CA. The classification of the explosion was accidental.

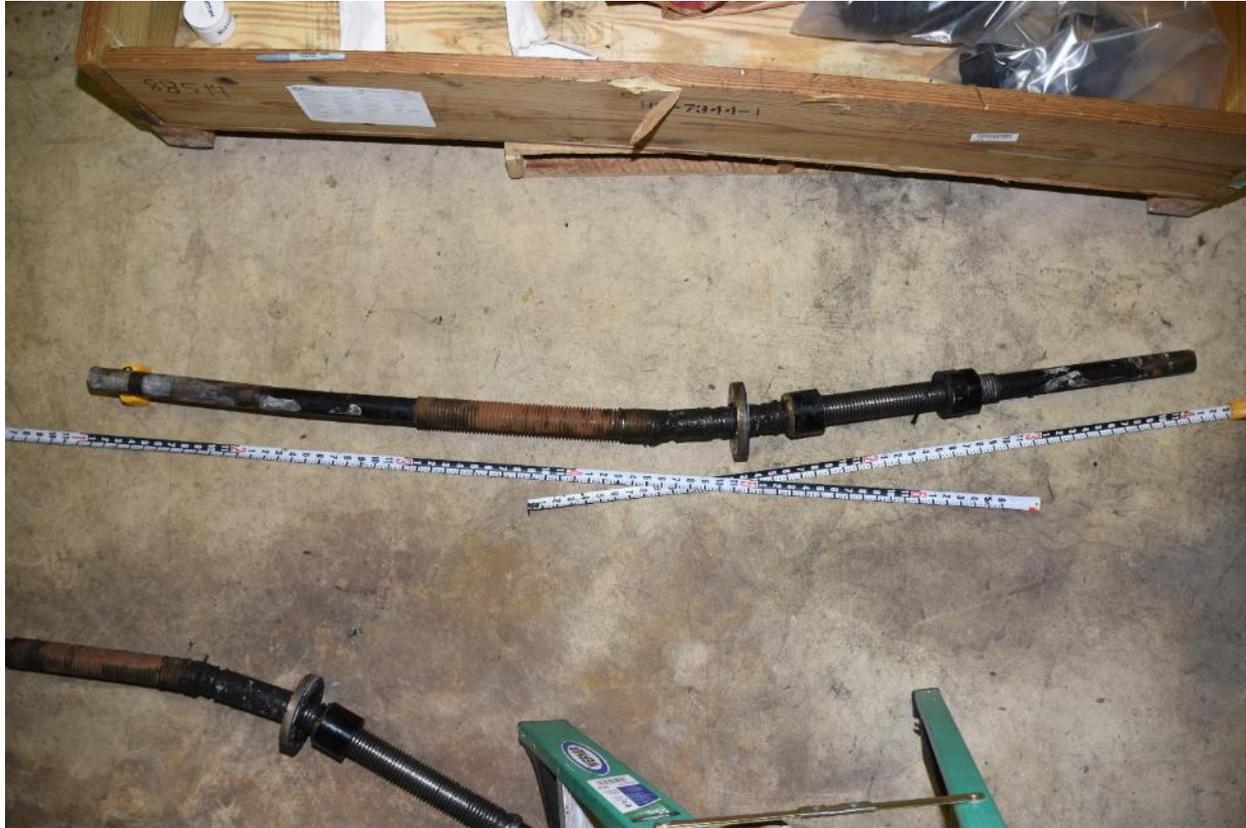
FIGURE 7

The lower threaded rod is shown in Figure 7. Figure 8 shows that the bronze threads of the left-side flanged collar have been sheared off and remain in the threads of the steel rod. Figure 9 shows that the right-side flanged collar has broken. The flange is broken away from the rest of the collar. The threads that had been inboard of the flange have been shear off and remain in the mating threads of the steel rod. The threads of the remainder of the collar are still intact and that portion of the collar turns freely on the steel threaded rod. The flanged collar that had been attached to the bottom of left side yoke (based on site photographs) is shown in Figures 10 and 11. All the threads have been sheared from this collar and the collar has a crack on a radial-axial plane through one of the bolt holes.

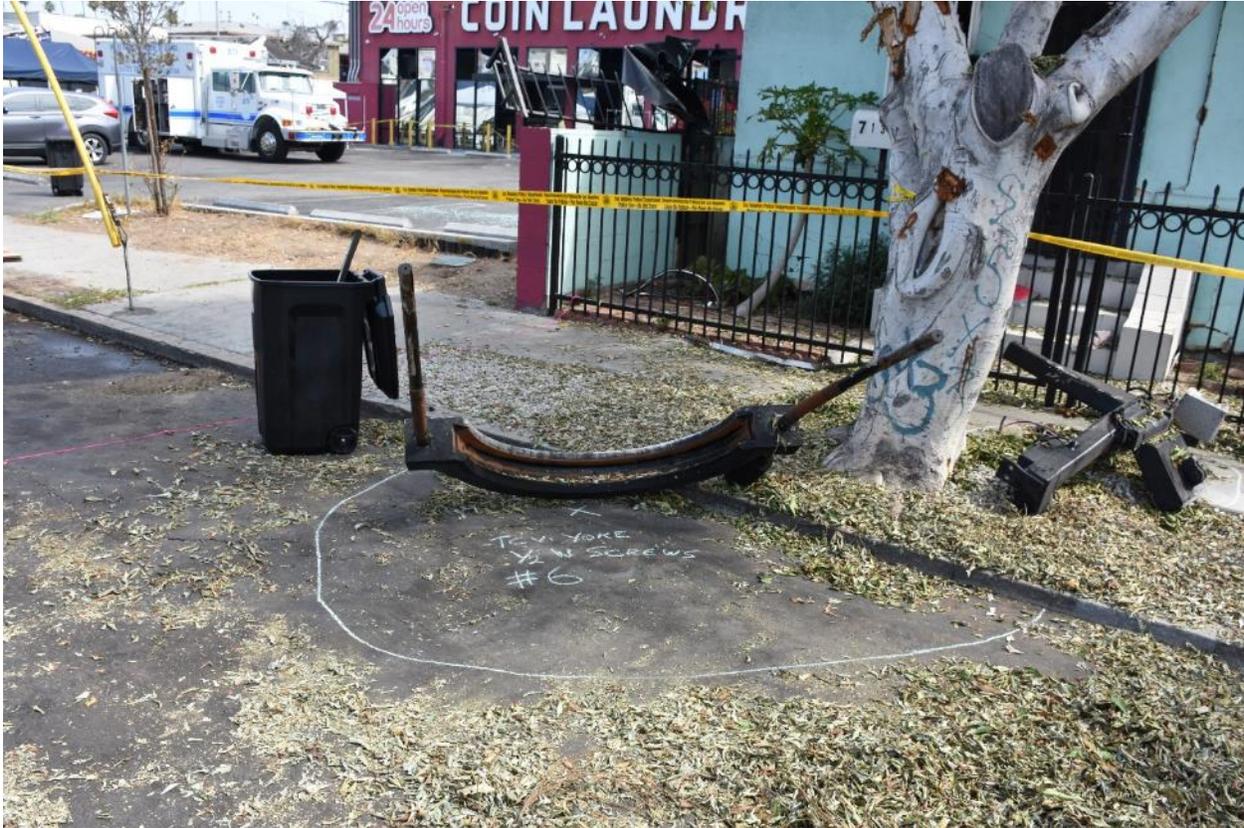
FIGURE 12

A scene photograph reproduced as Figure 12 shows that the threaded rods remained with the right-side yoke. The scene photographs reproduced as Figures 13 and 14 show that the left-side yoke has separated from the threaded rod and struck an automobile.

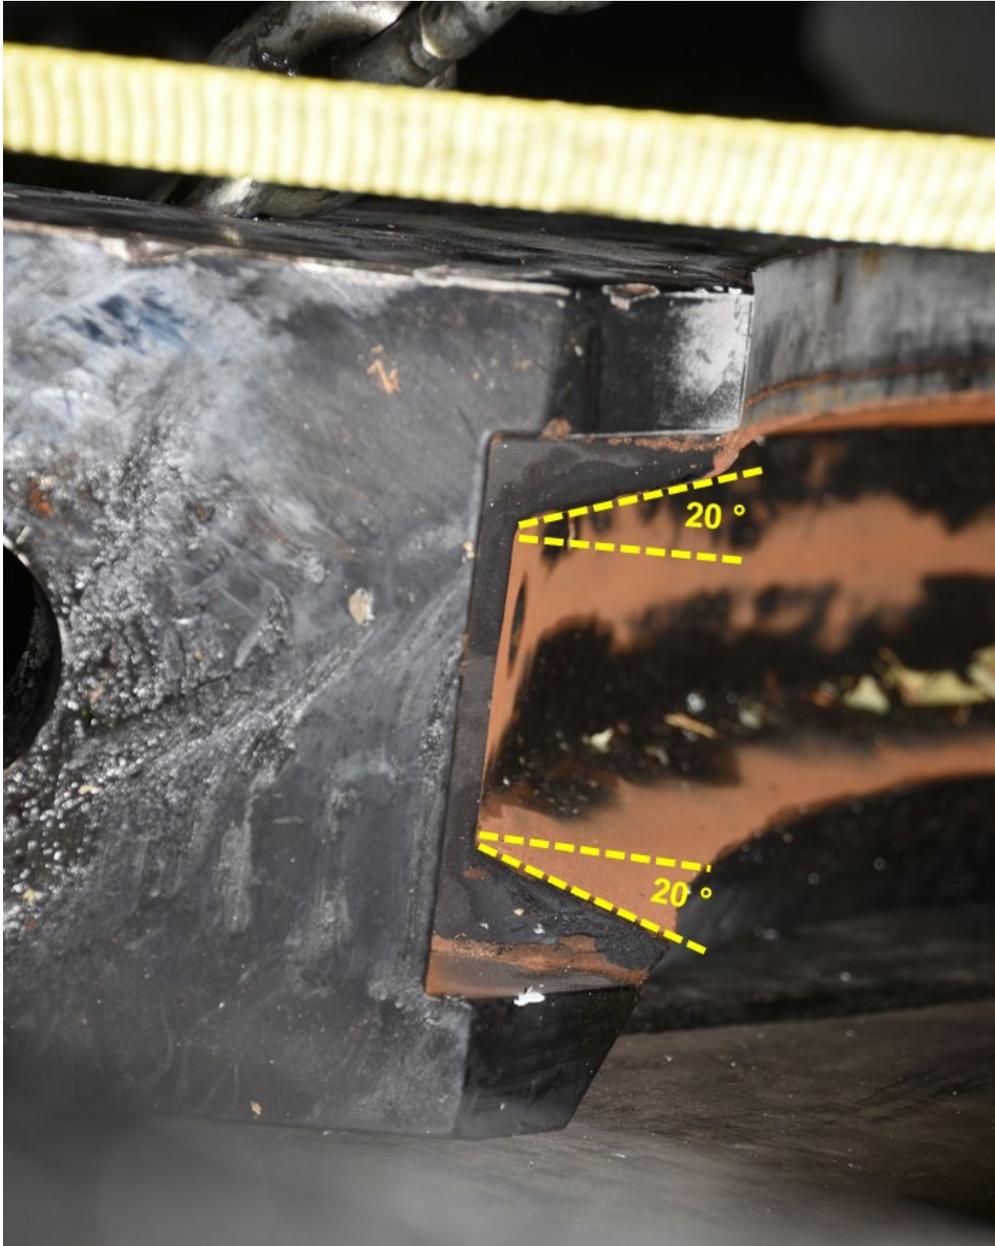
FIGURE 15

As shown in the image of the harden steel insert in the yoke of Figure 15, the clamping surface between the vessel and door flanges and the yoke surface is sloped at approximately 20 degrees from the plane of the door. This results in part of the outward explosion force on the door being directed radially outward against the yokes and part of that load is carried by the flanged collars on the threaded rods.

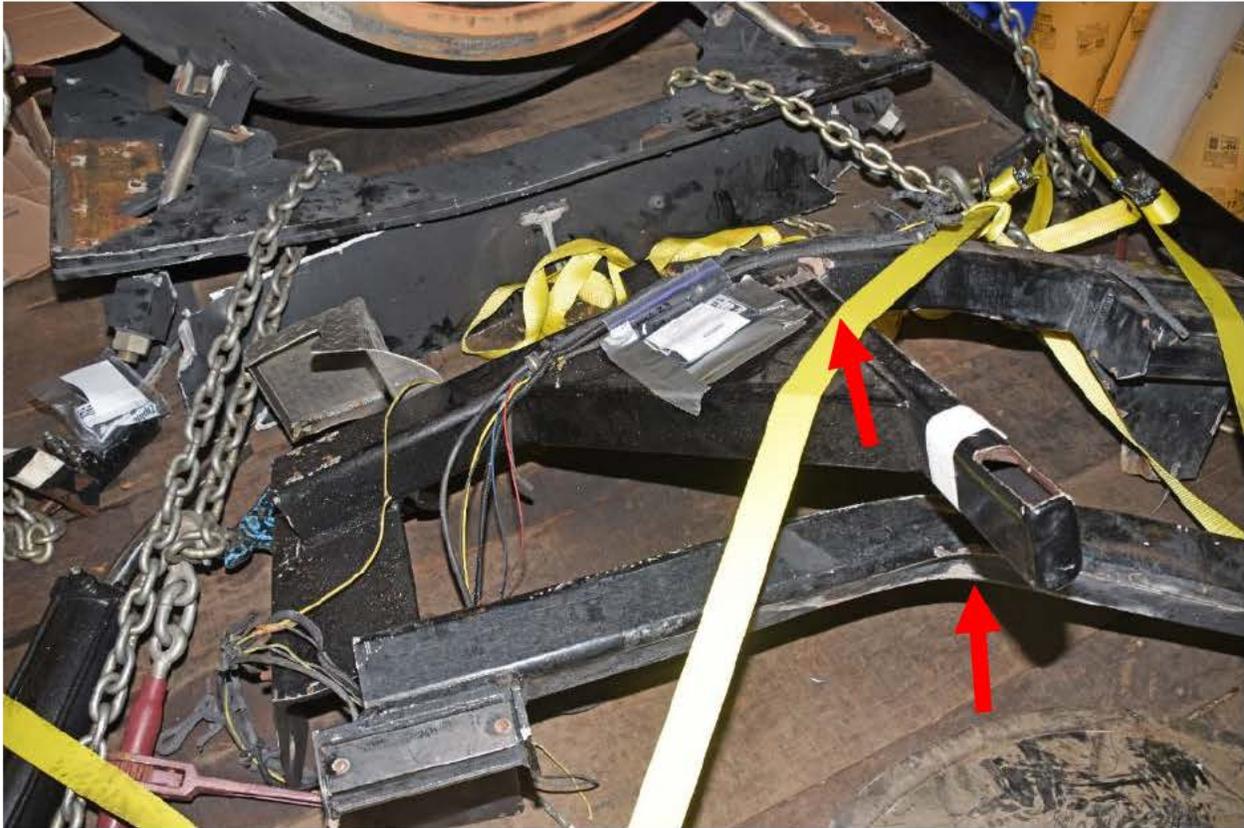
FIGURE 16

Examination of evidence at the ATF Los Angeles facility showed that the vertical columns of the vessel support structure had been bent severely outward by impact from the yokes as they travelled laterally away from the door. This is indicated by the red arrows on Figure 16. The corresponding impact witness marks on the yokes are shown in Figures 17 and 18.

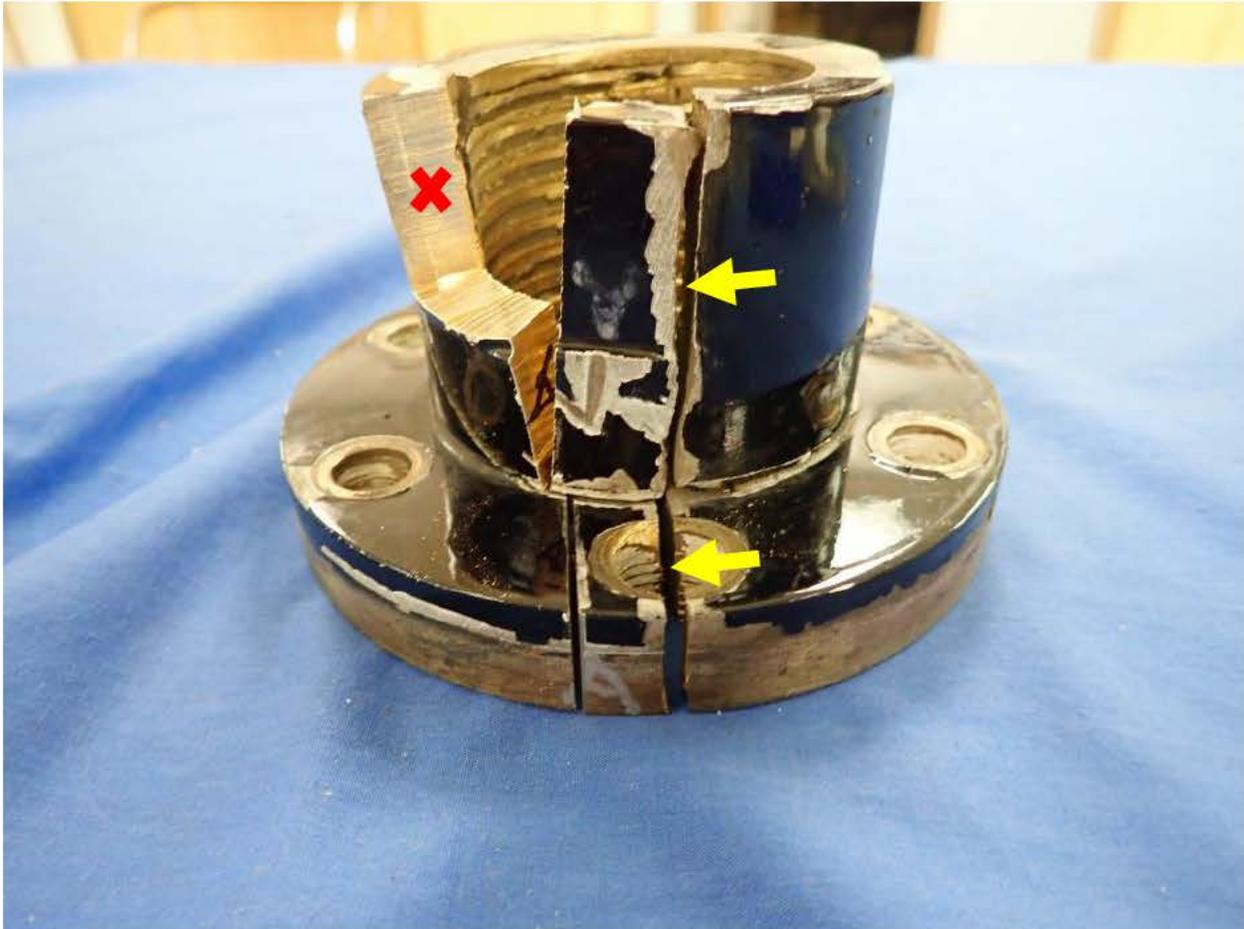
FIGURE 20

The top left-side flanged collar is shown in Figure 19. It was sectioned to facilitate direct examination of the longitudinal fracture and to obtain a section through the sheared threads for metallographic examination as shown in Figure 20.

A section on the radial-axial plane indicated by the red X on Figure 20 was cut for metallographic examination of the sheared threads. This section after mounting, polishing, and etching is shown in Figure 45. Higher magnification images in Figures 46 and 47 show the tearing and shearing of the threads. The general microstructure of this collar is shown in Figures 48 and 49 and is also typical microstructure for C954 cast aluminum bronze.

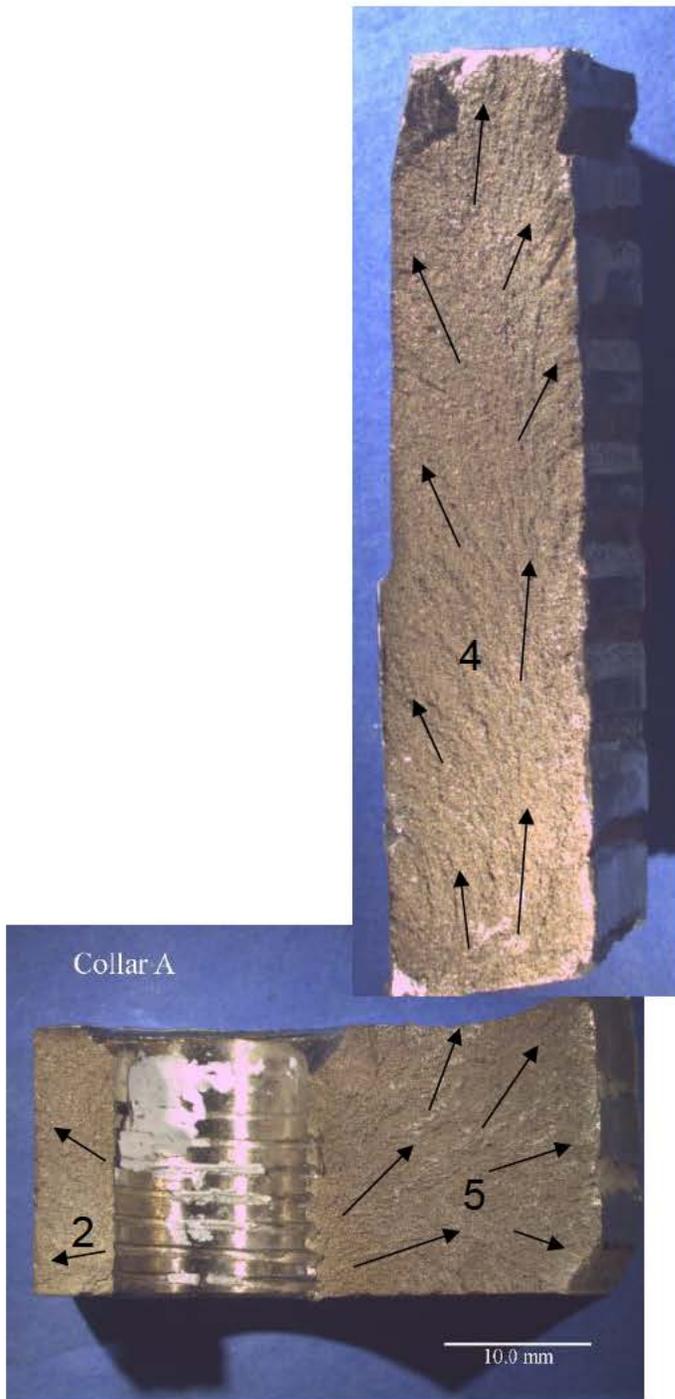
FIGURE 21

The fracture surfaces indicated by the yellow arrows on Figure 20 are shown in the stereo microscope images of Figure 21. The fracture appears to be a onetime overload fracture starting at the bolt hole in the flange. The black arrows show the fracture propagation direction.

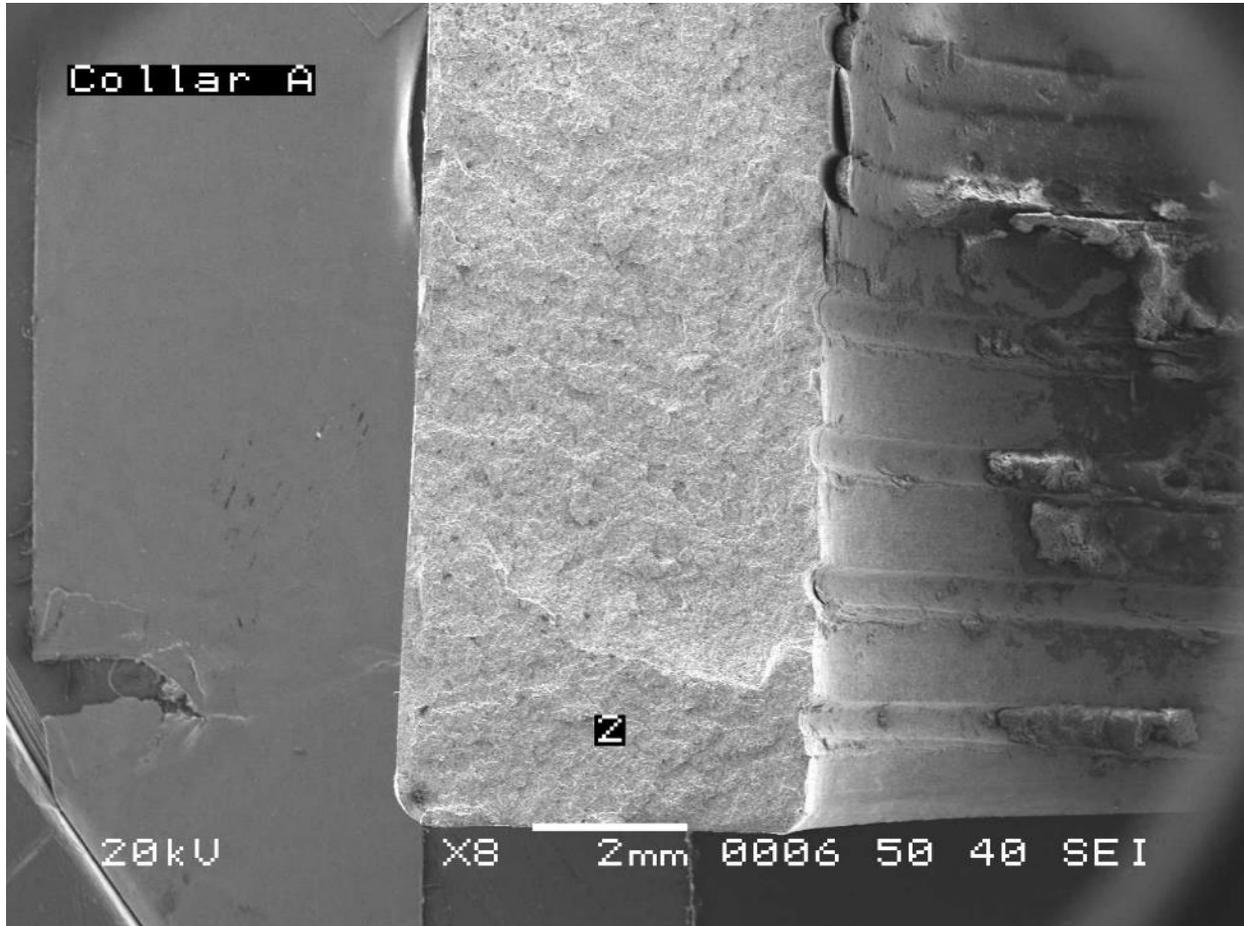
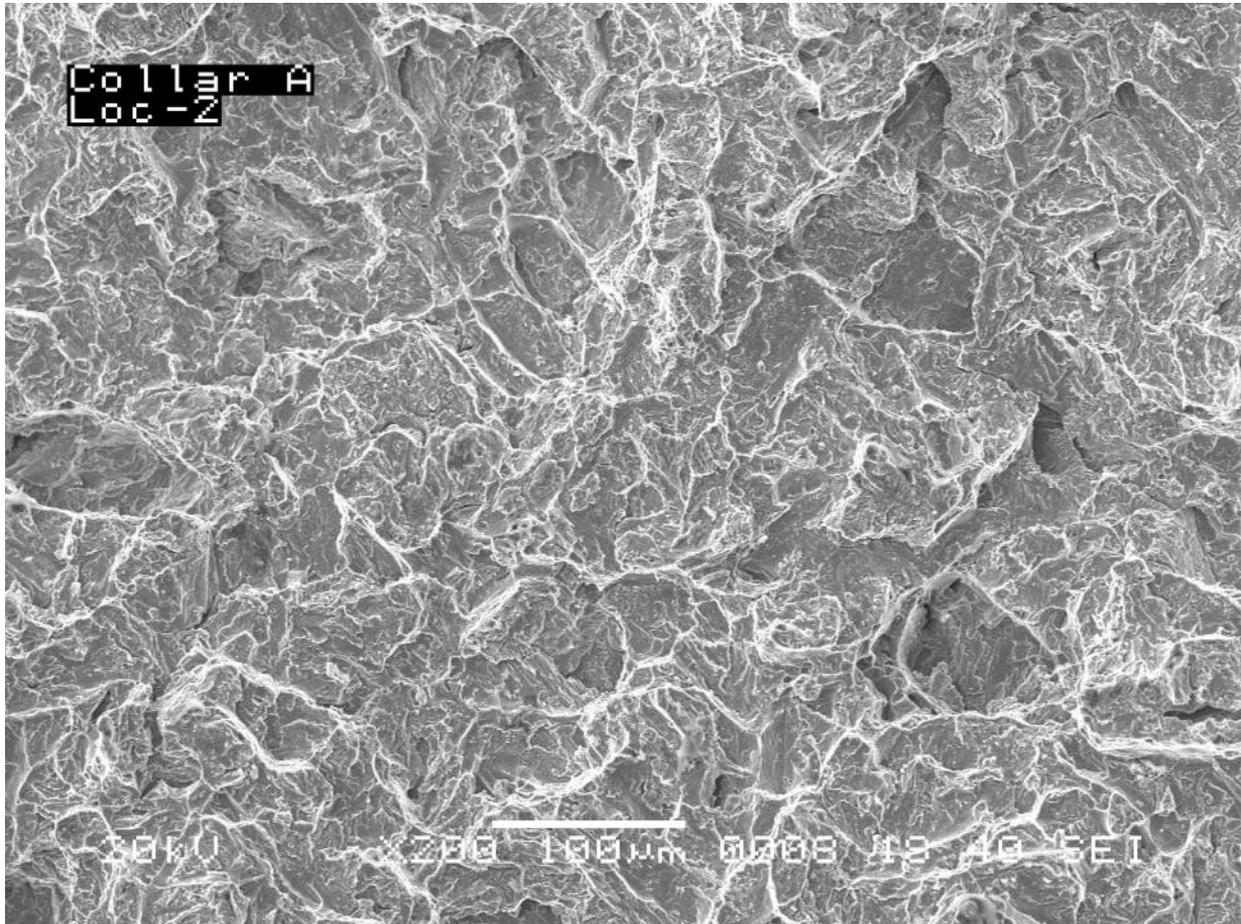
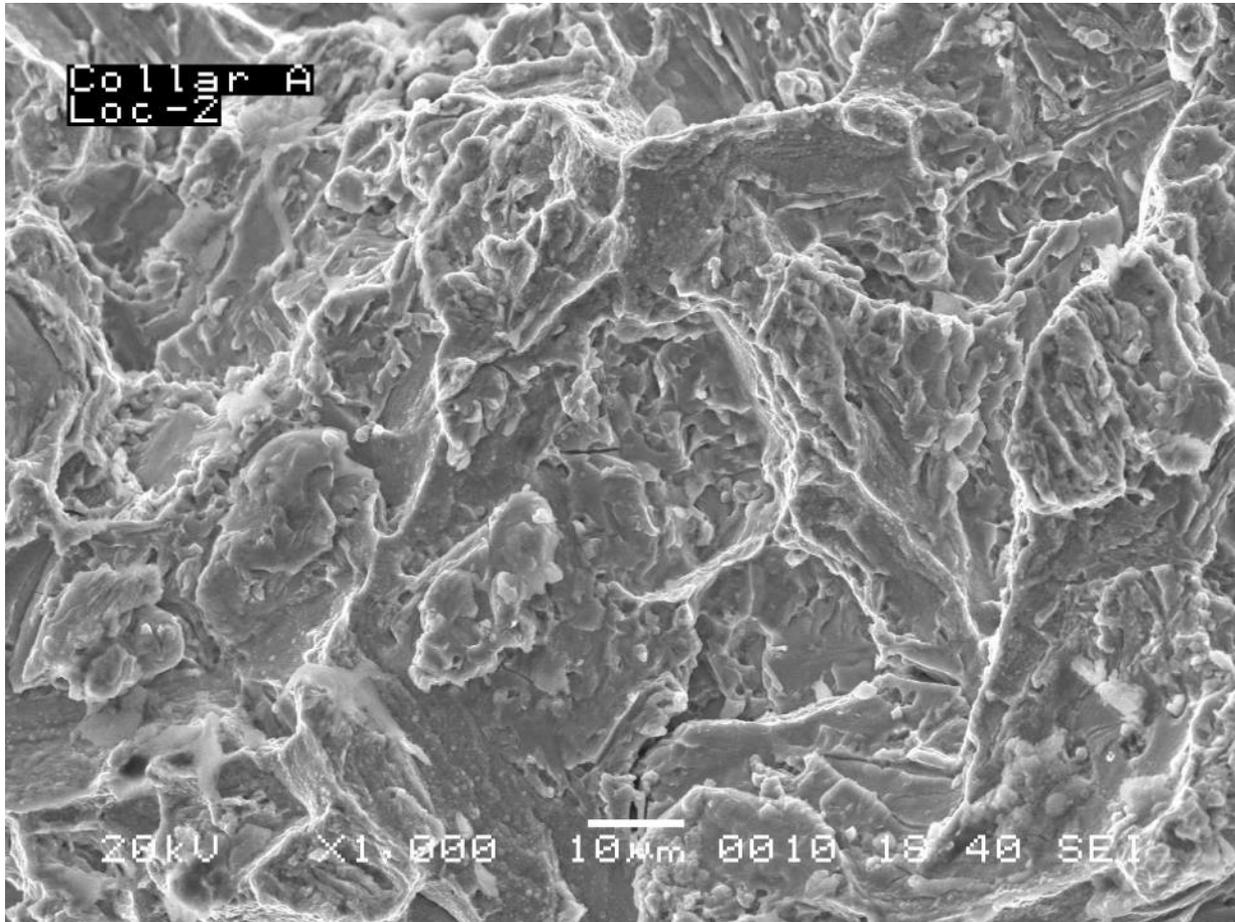
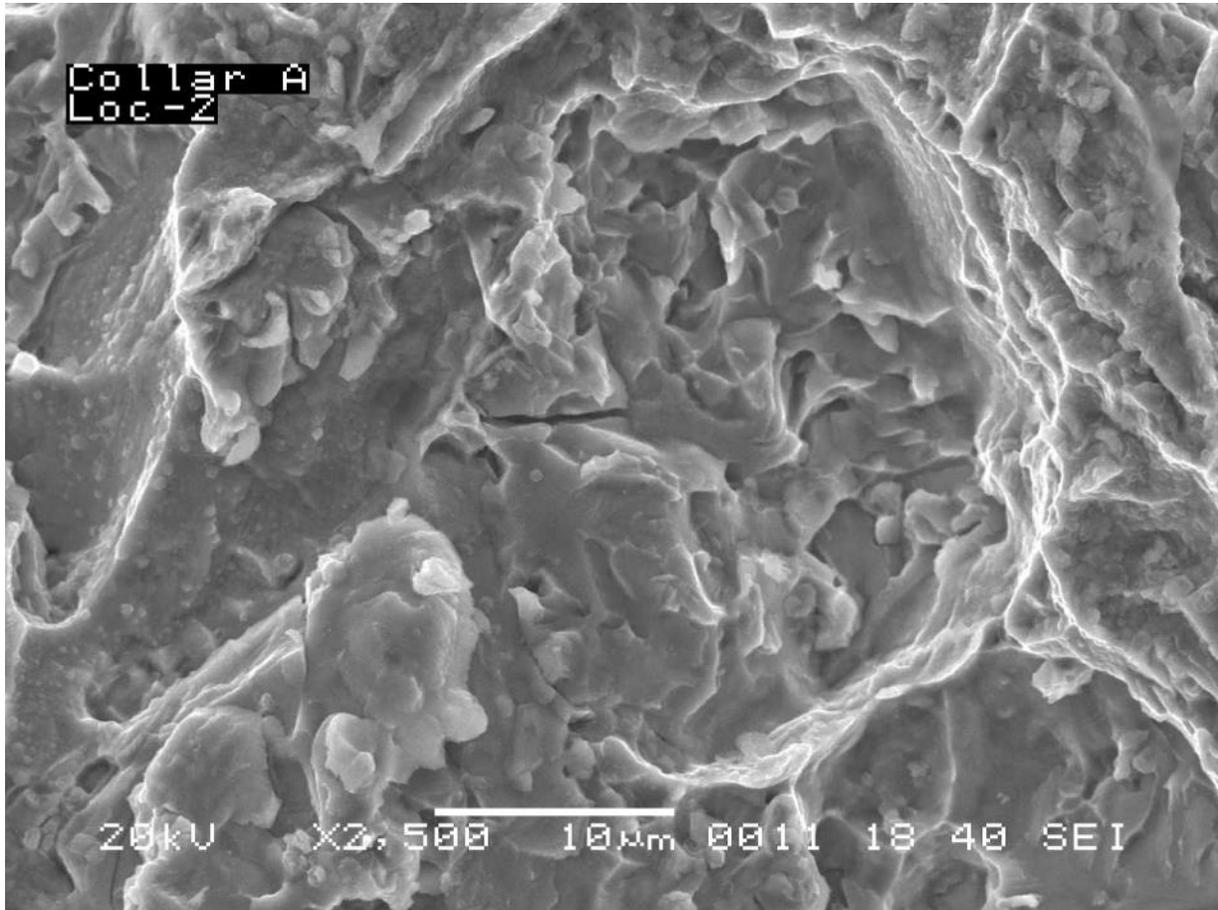
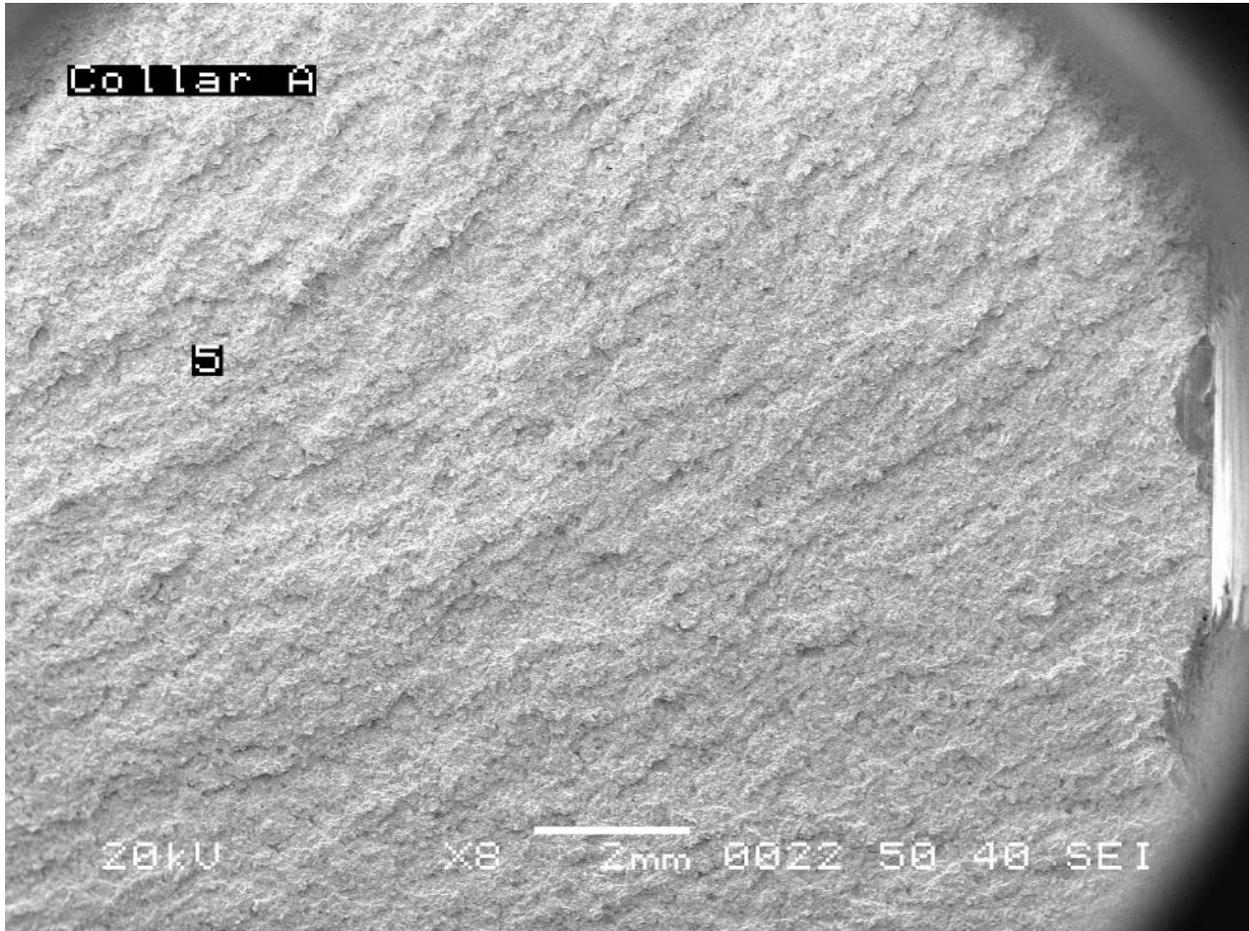
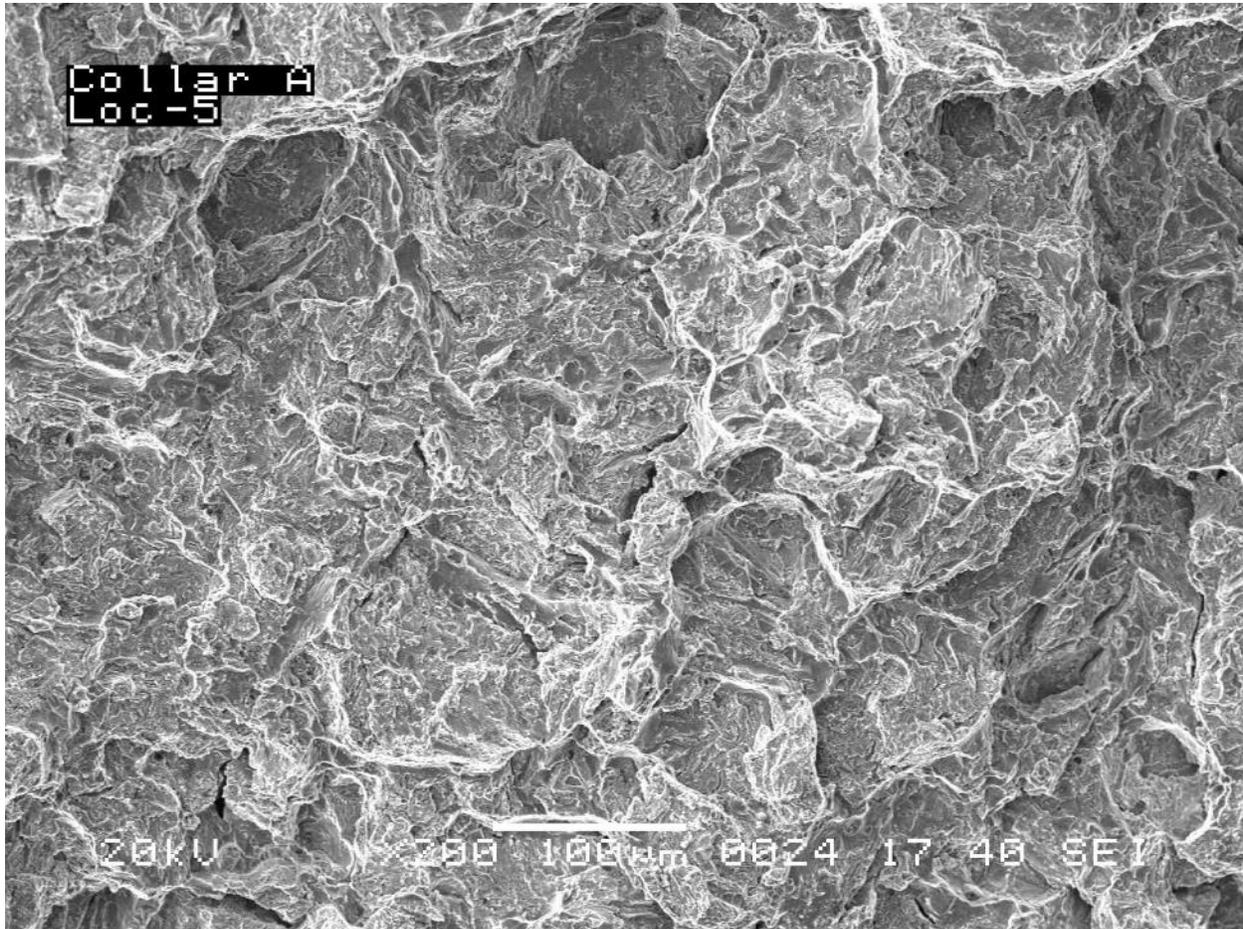
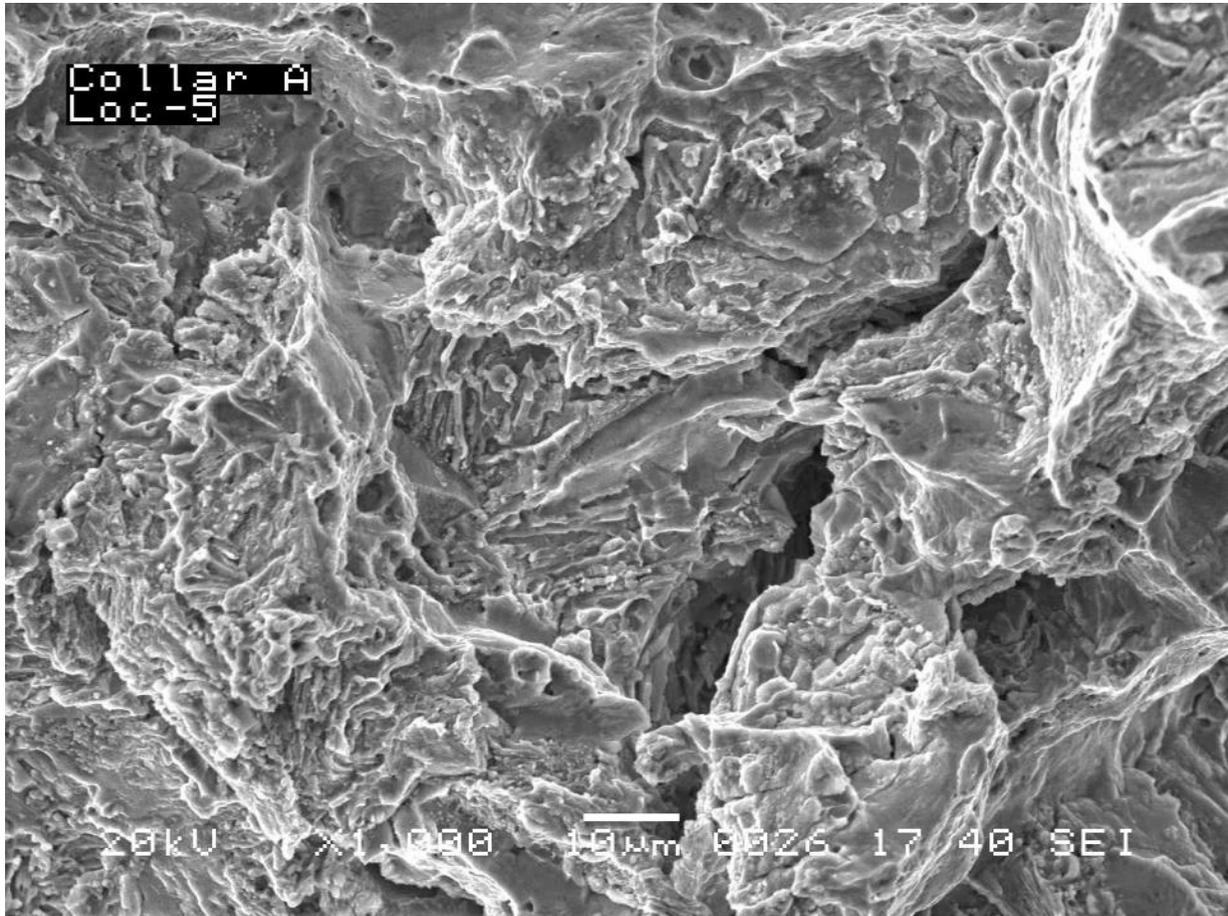
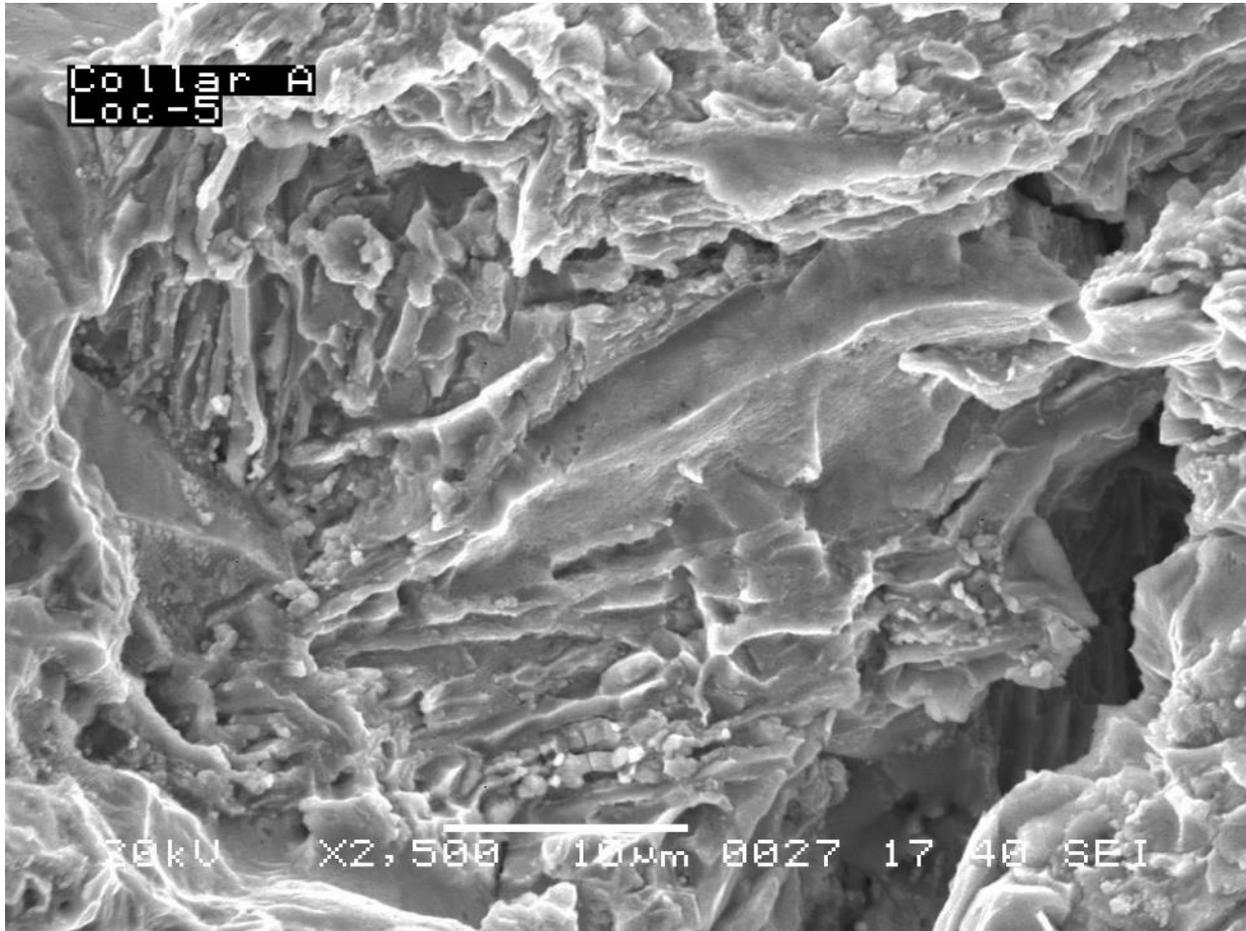
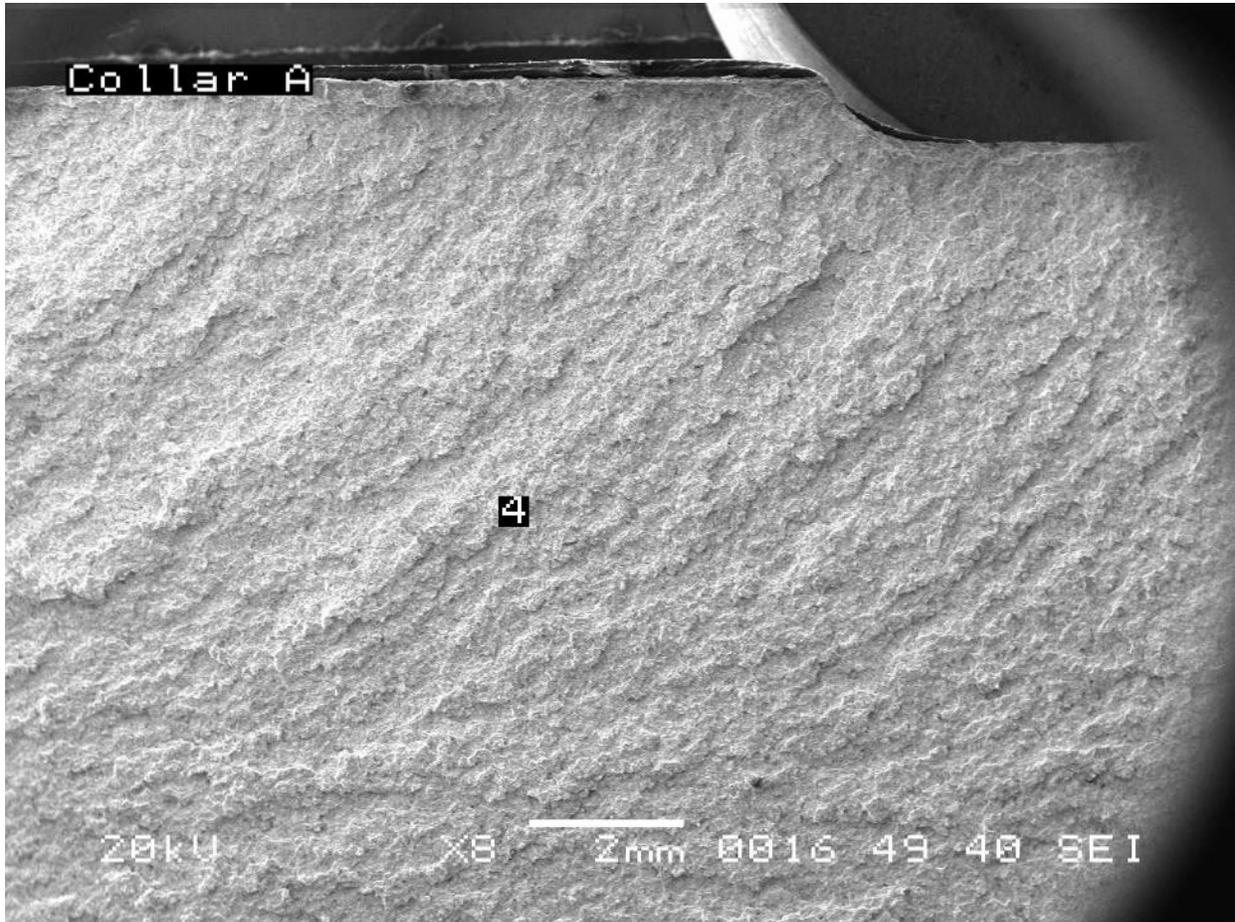
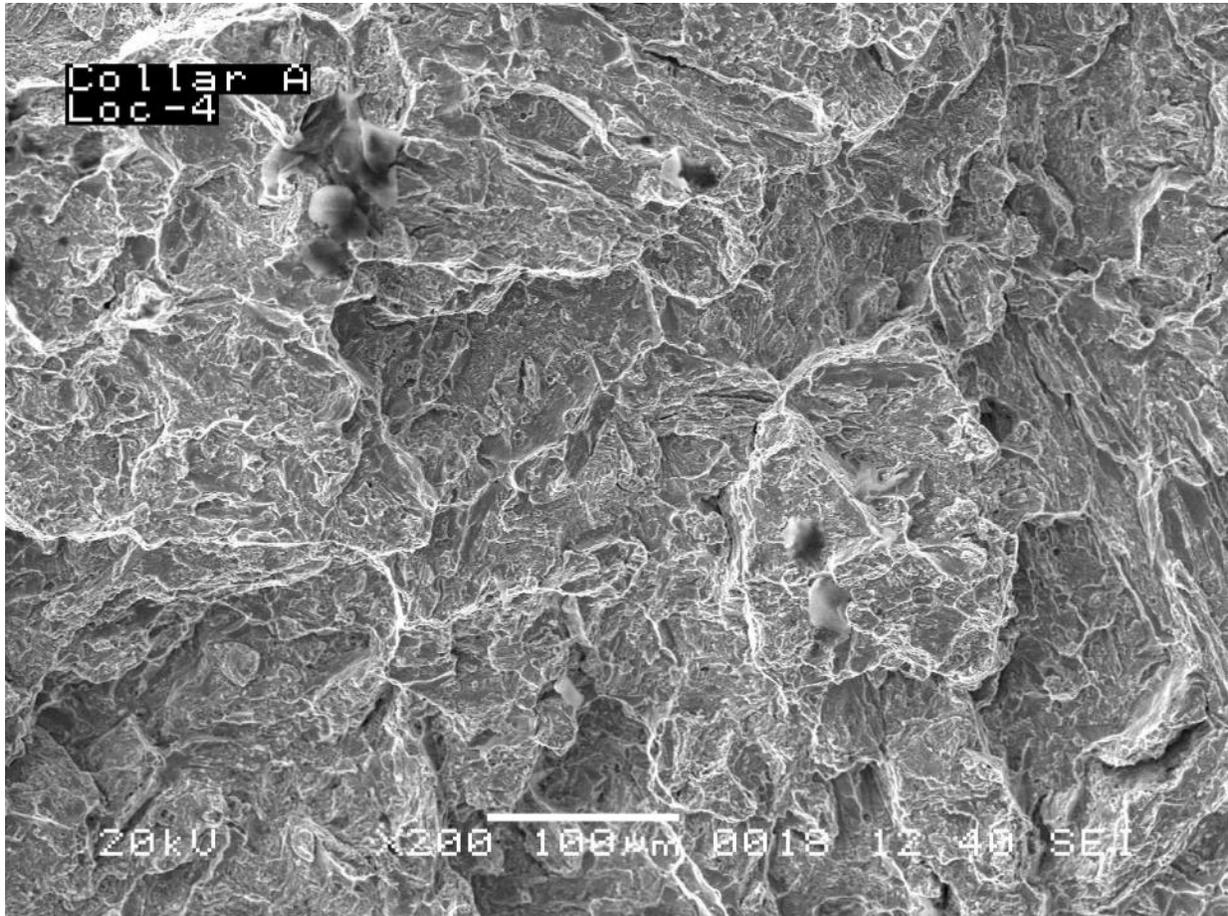
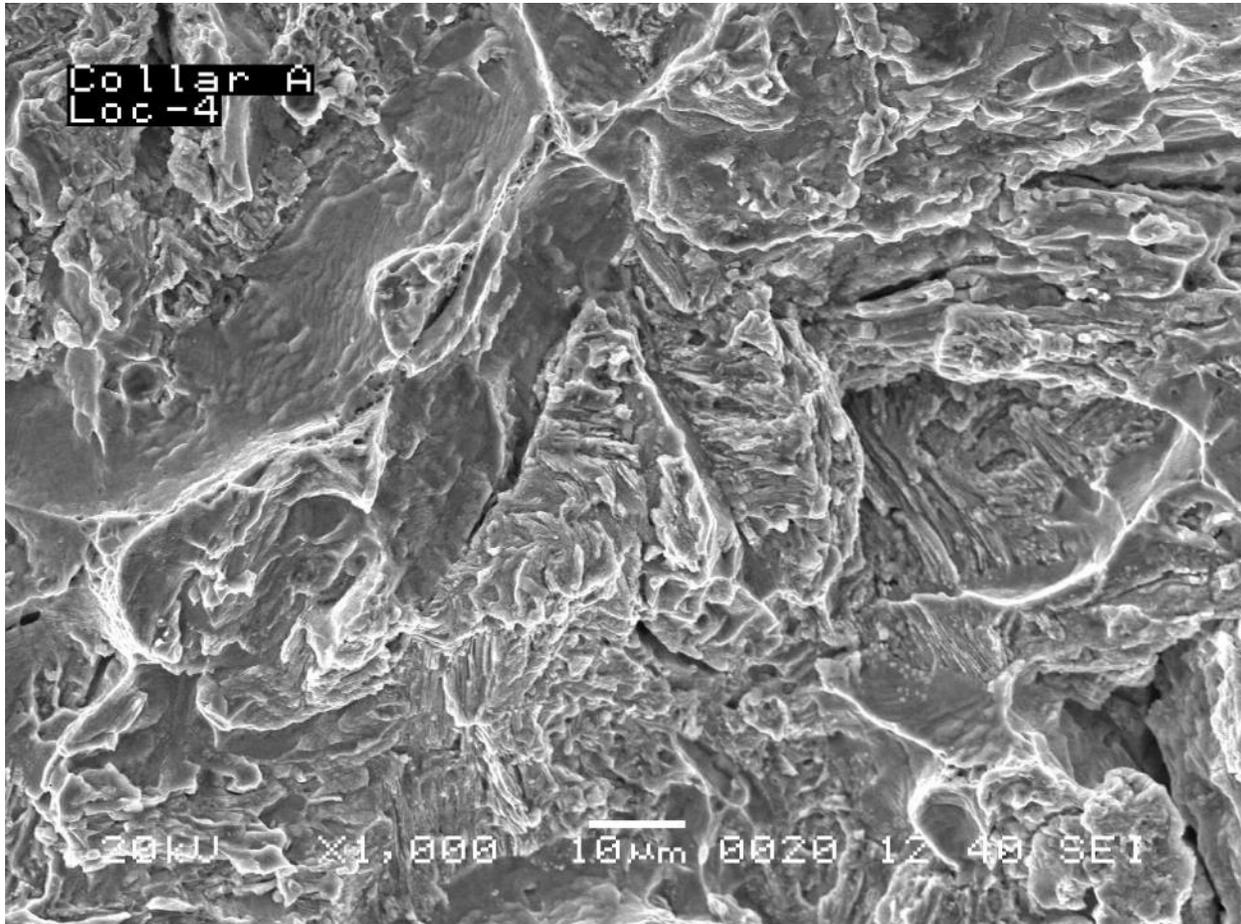
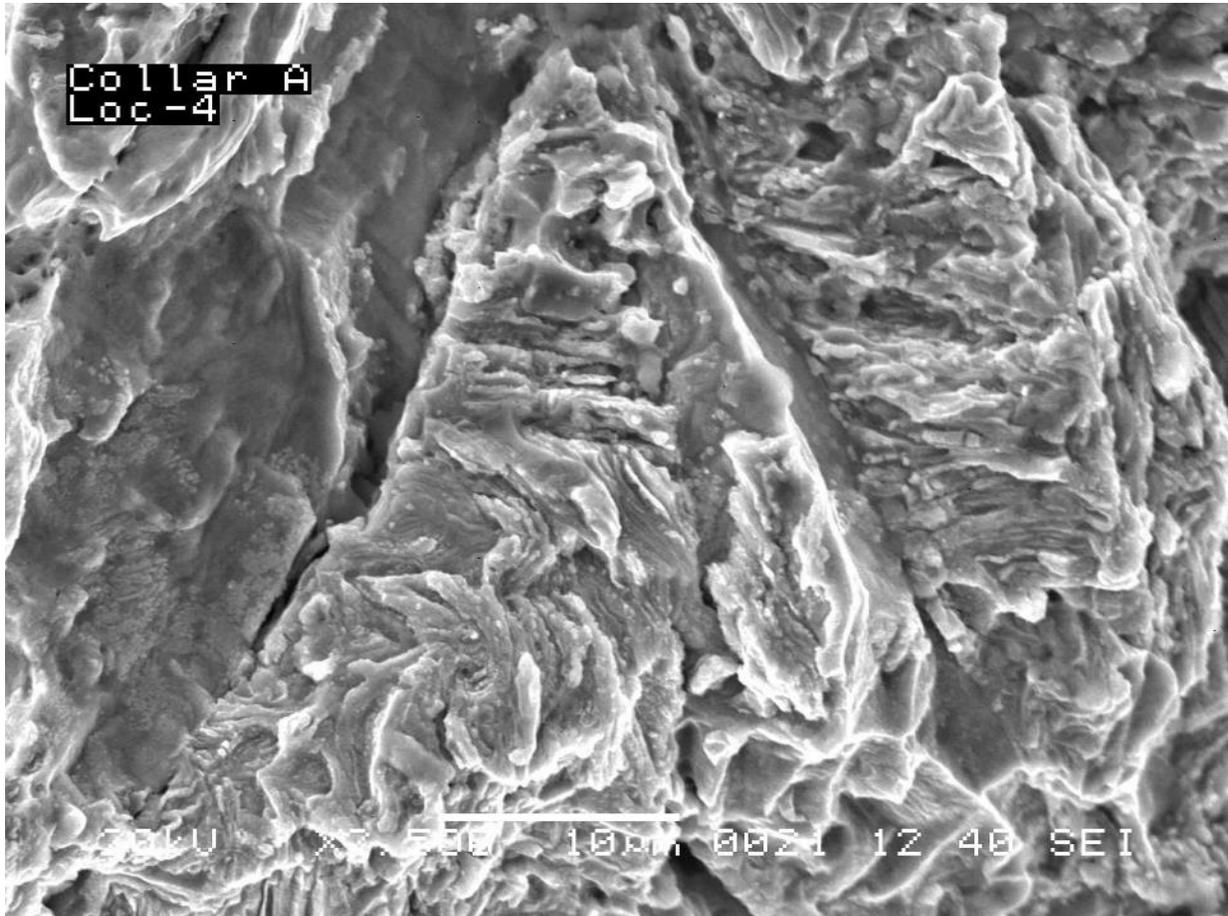
The fracture was examined with the scanning electron microscope (SEM). SEM images obtained at Location 2, 5, and 4 (on Figure 21) are shown in Figures 22 through 33. These images show a mostly brittle, onetime overload fracture morphology. This confirms that the fracture occurred as a onetime, rapid event and that there was no prior slow crack growth.

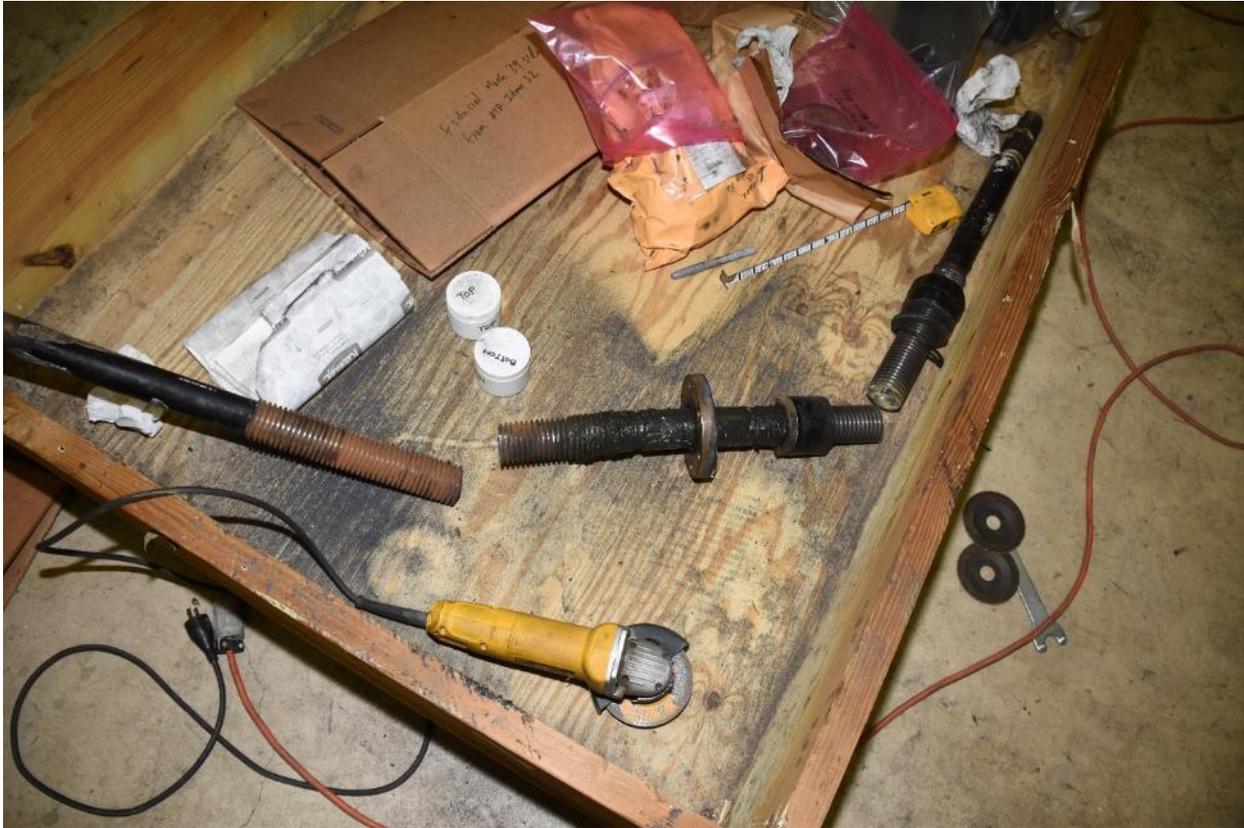
FIGURE 34

It was noted that the collars of the broken flanged collars on the right-side still rotated smoothly on the threaded rods. To remove one of these collars and to facilitate cleaning of the threaded rod, a section was cut from the bottom threaded rod as shown in Figure 34.
