Title of Investigation: 716 E. 27th Street Explosion	Investigation Number: 784020-21-0014	Report Number: 56
---	---	----------------------

ATF National Response Team (NRT) Origin and Cause Determination.

From 7/2/21 – 7/6/21, Bureau of Alcohol, Tobacco, Firearms and Explosives (ATF) National Response Team (NRT) and Los Angeles Police Department (LAPD) personnel conducted a post blast scene examination of an explosion that occurred while LAPD bomb squad personnel were conducting a disposal operation in a Total Containment Vessel (TCV). The explosion occurred on East 27th Street just east of San Pedro Street in the city of Los Angeles, CA. The classification of the explosion was accidental.

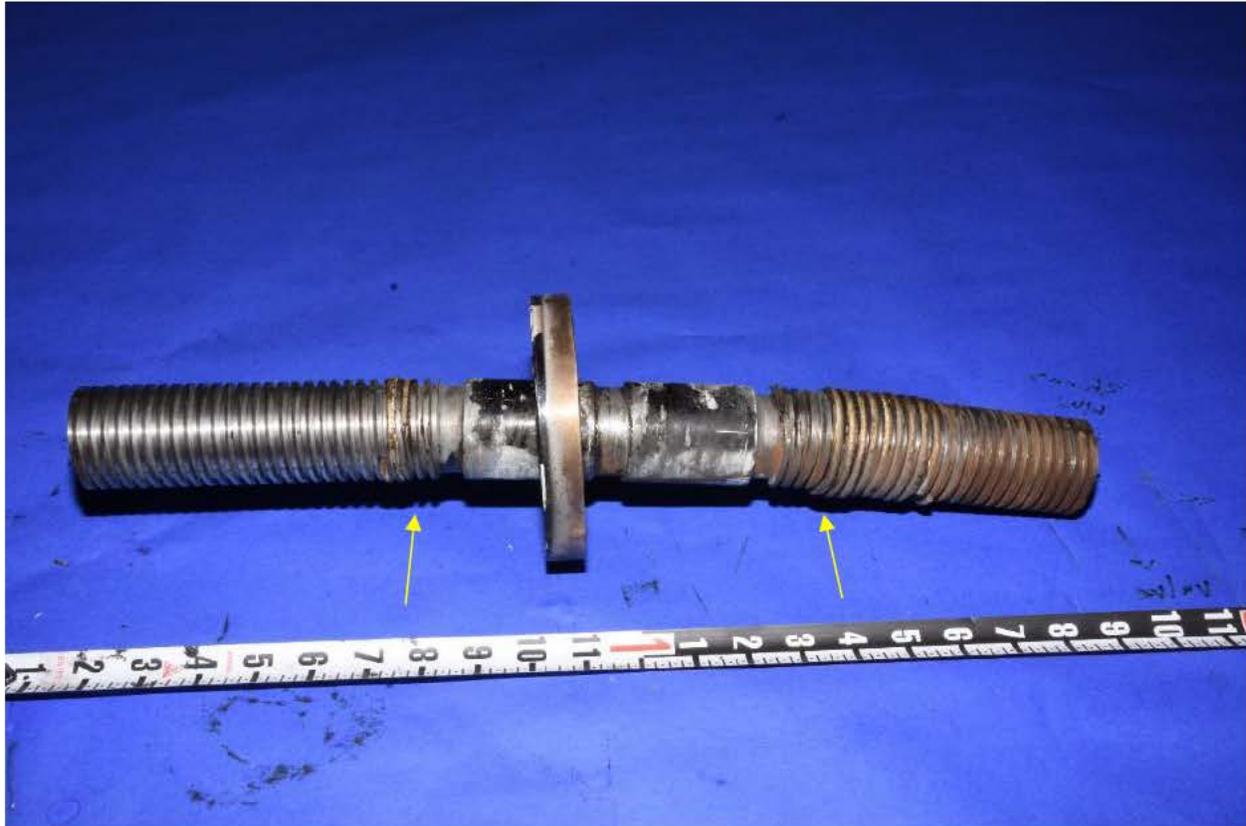
FIGURE 35

The removed section of the bottom threaded rod after degreasing is shown in Figure 35. The sheared off collar threads are visible. The distance between where the threads were sheared off is consistent with the yokes having been in the fully closed position when this occurred. The threads which sheared off the left-side flanged collar are shown in Figures 36 and 37. The threads which had sheared off from the flange on the right-side are shown in Figures 38 and 39. This type of shear failure of entire threads does not occur slowly over time; it occurs as a rapid onetime event. The longitudinal break in the threads visible in Figure 37 shows that the longitudinal cracking of the collar occurred slightly before the threads were completely sheared off.

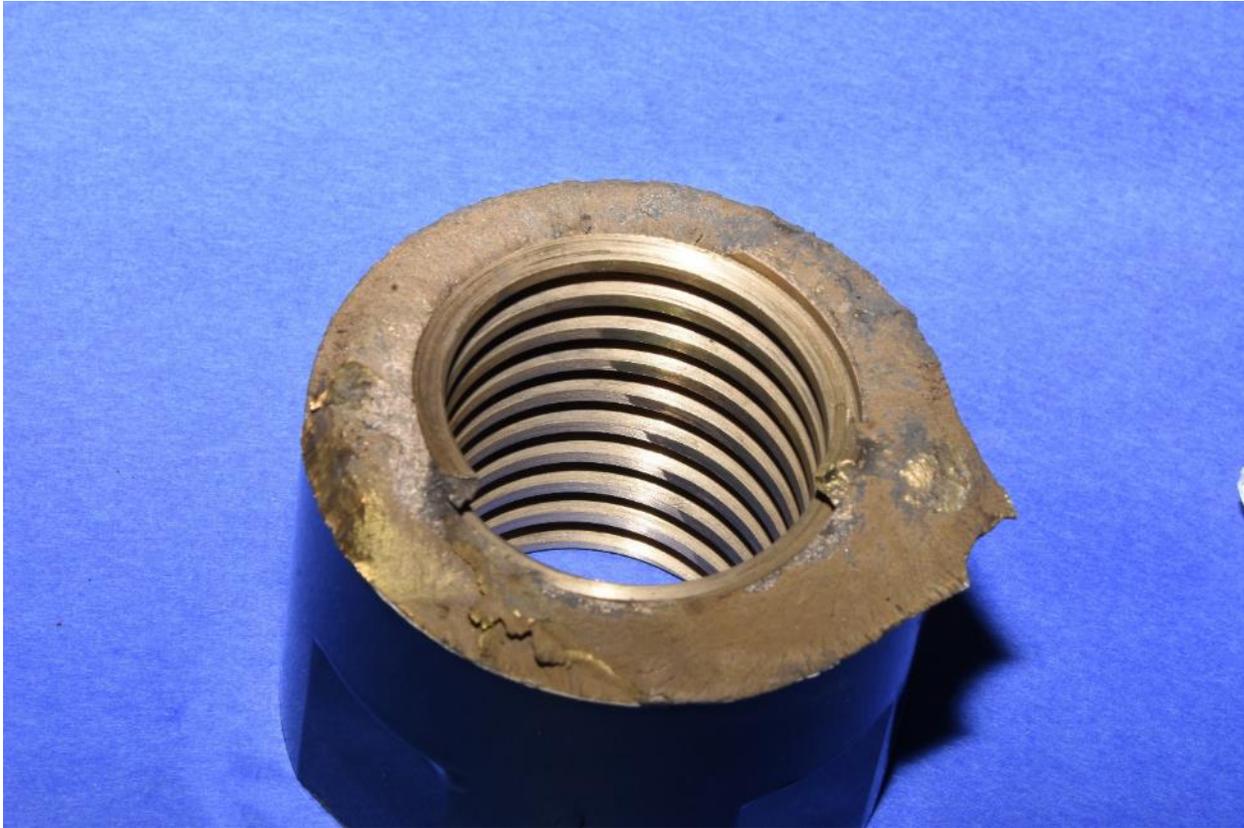
FIGURE 40

The portion of the right-side collar that had remained intact is shown in Figures 40 and 41 after removal from the threaded rod. The threads are in good condition and undamaged. This shows that the threads of the bronze collars had not worn down in service prior to the subject incident.

A section on a radial-axial plane was cut at the location indicated by the dashed red line on Figure 40 for metallographic examination. This section after mounting, polishing, and etching is shown in Figure 42. The thread profile shows no indication of significant wear. Higher magnification images in Figures 43 and 44 show typical microstructure for C954 cast aluminum bronze.

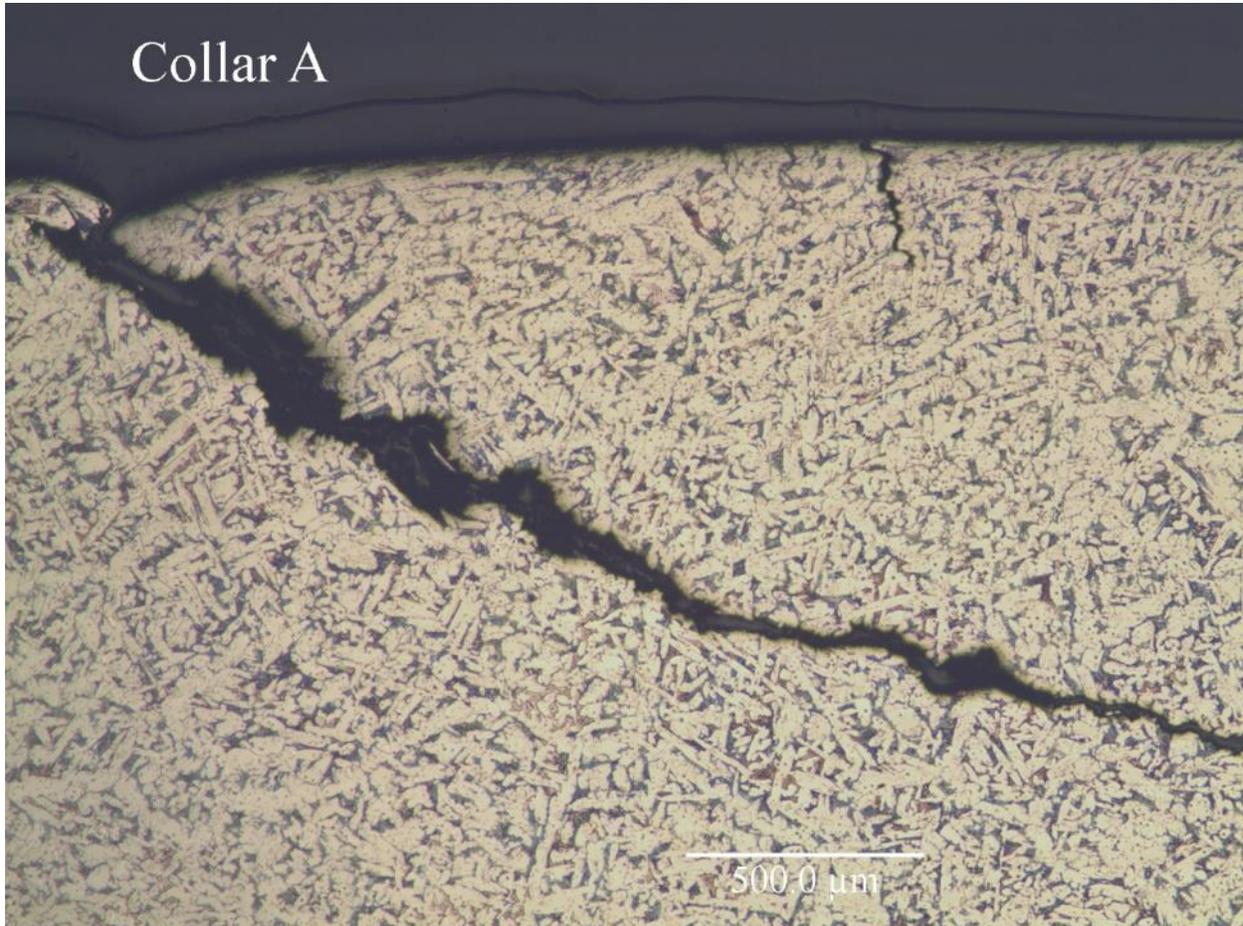
FIGURE 45

A section on the radial-axial plane indicated by the red X on Figure 20 was cut for metallographic examination of the sheared threads. This section after mounting, polishing, and etching is shown in Figure 45. Higher magnification images in Figures 46 and 47 show the tearing and shearing of the threads. The general microstructure of this collar is shown in Figures 48 and 49 and is also typical microstructure for C954 cast aluminum bronze.

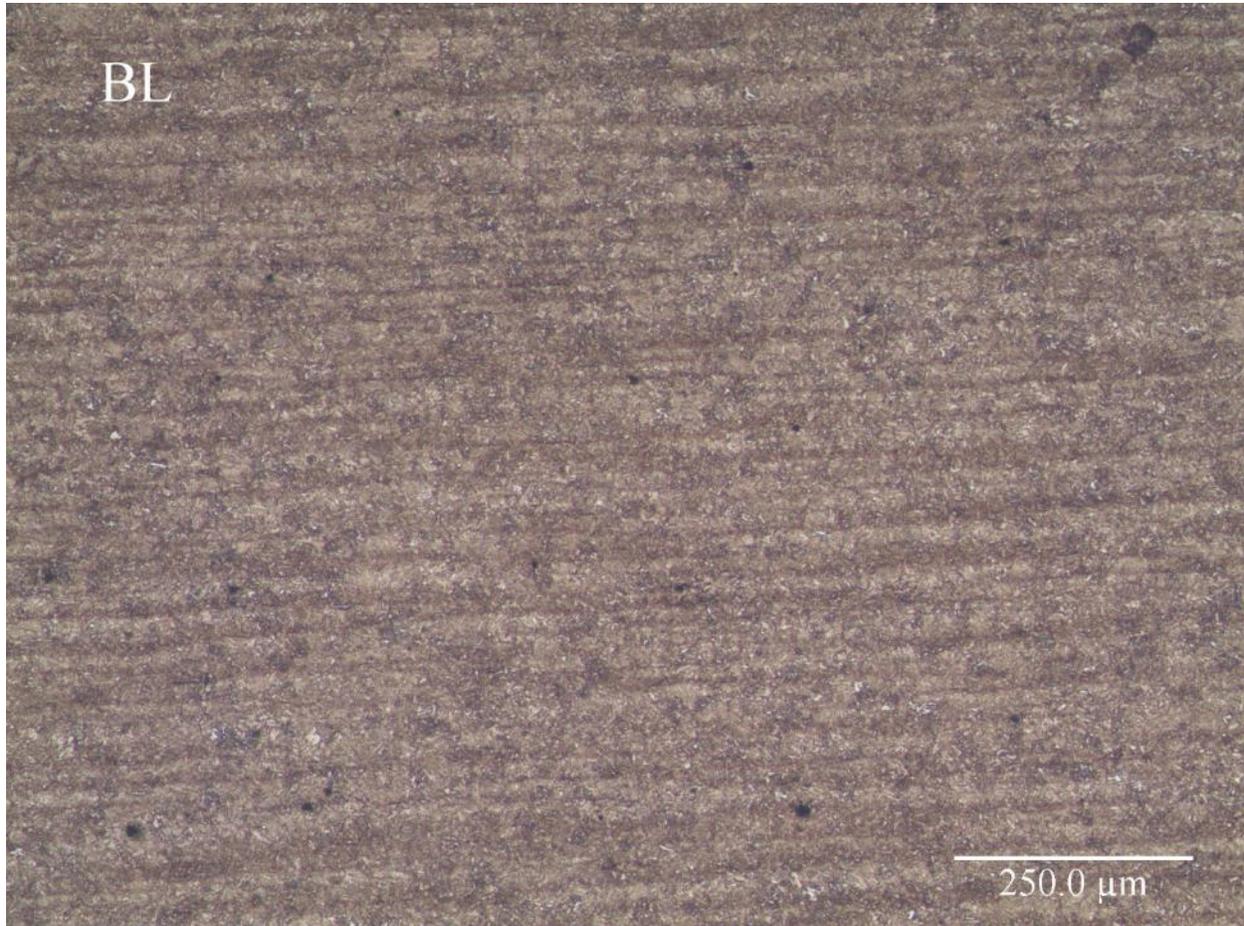
FIGURE 50

A radial-axial section through the steel threaded rod after mounting, polishing, and etching is shown in Figure 50. The higher magnification images in Figures 51 and 52 show typical microstructure for quenched and tempered alloy steel.

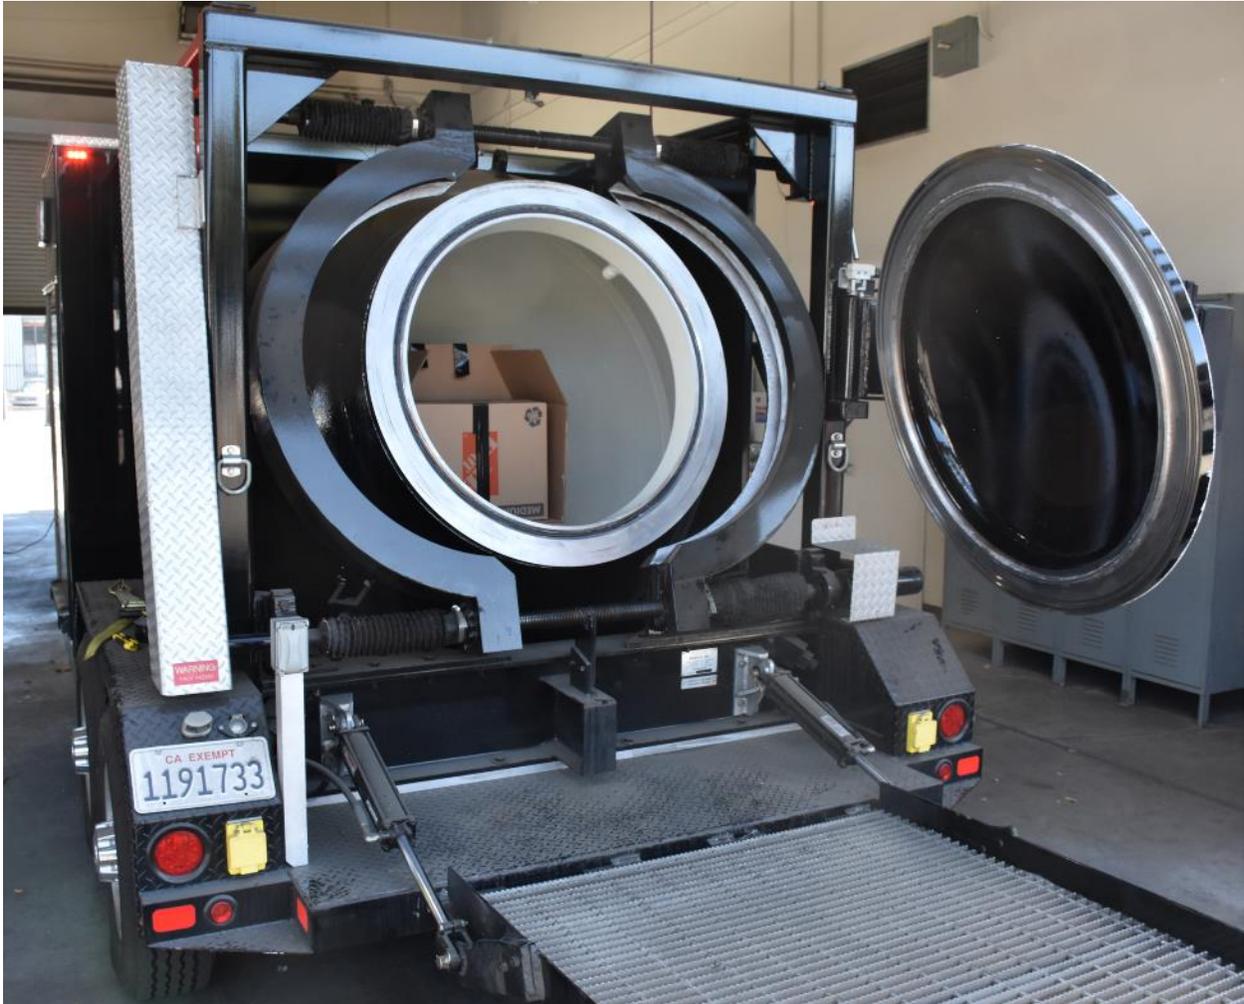
FIGURE 53

As mentioned above, I traveled to Los Angeles to examine damage to the threaded rods on another LAPD TCV. Photographs of this vessel by others are reproduced as Figures 53 and 54 with the door closed and opened, respectively. The yokes and rods had been removed as shown in Figure 55. After significant effort, a rod was removed as shown in Figure 56 to allow examination of the internal threads of a collar to determine the amount of wear.

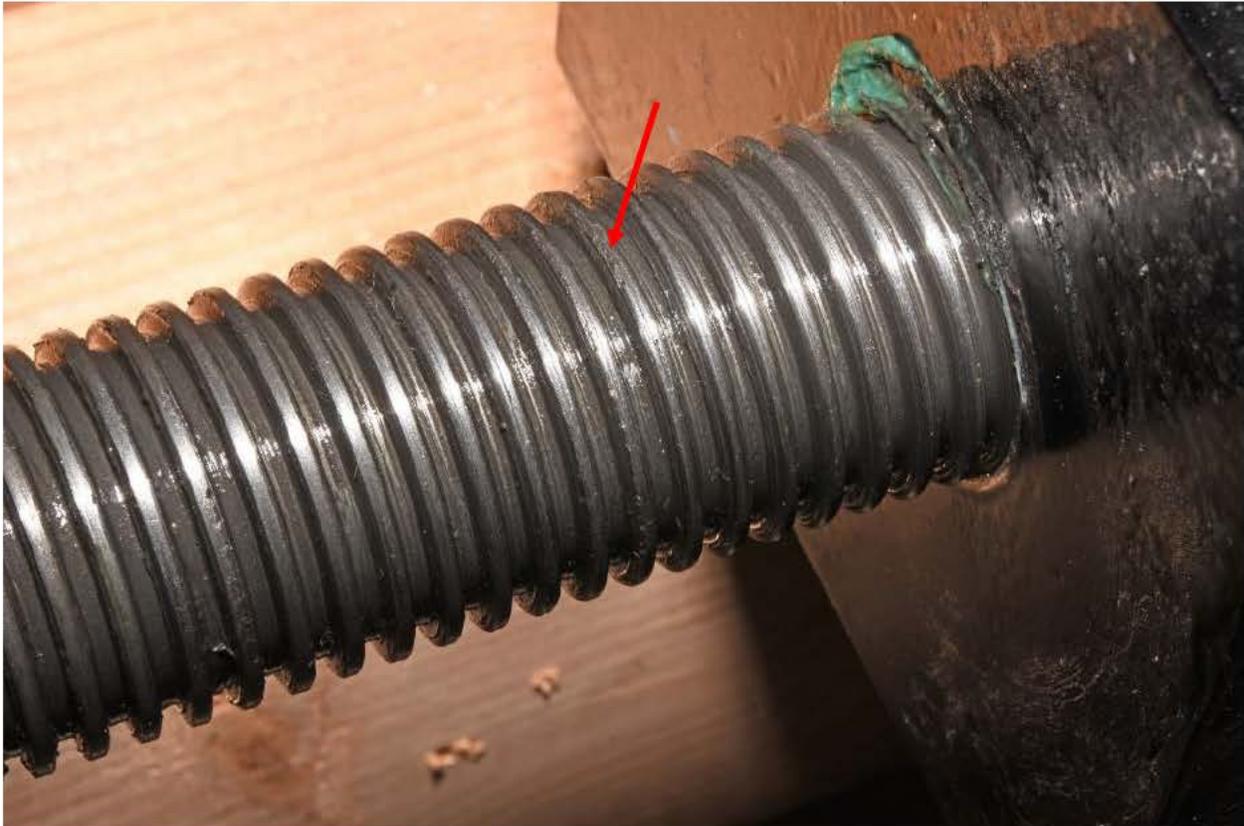
FIGURE 57

The damage to the threads of the steel rod is shown in Figures 57 and 58 (red arrows). This is galling type of damage caused by lubrication failure. It occurs when surfaces of metals that have a high coefficient of friction slide across each other under high load.
